</div>	<b>GROUP</b> <b>Chassis</b>	<b>MODEL</b> <b>Sedona (VQ)</b>
	<b>NUMBER</b> <b>018</b>	<b>DATE</b> <b>November 2007</b>
<h2>TECHNICAL SERVICE BULLETIN</h2>		
<b>SUBJECT:</b> <p style="text-align: center;">SEDONA (VQ) ABS/ESC WARNING LAMP ON – POOR          GROUNDS</p>

## SEDONA ABS/ESC WARNING LAMP ON - POOR GROUNDS

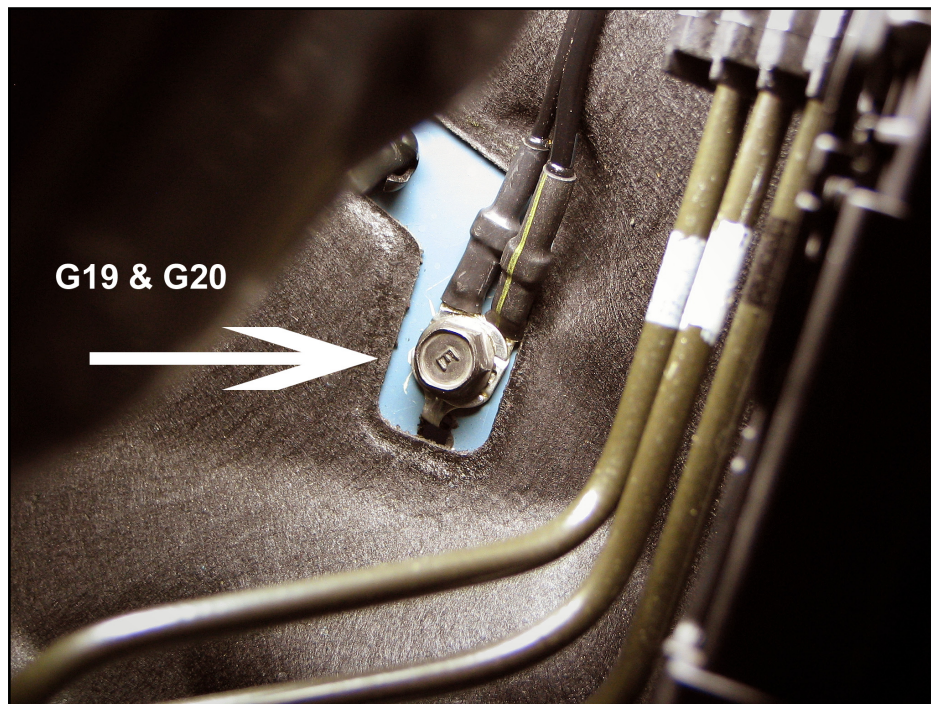
Ground Point G19 – G20

Some 2006 – 2007 Sedona (VQ) vehicles with a production date earlier than March 8, 2006 may exhibit a customer concern of an ABS/ESC Warning Lamp (MIL) being illuminated. Various DTC's such as C2402 or U0001 may also be stored in the control module – OR – the GDS Scan Tool may not be able to communicate with the ABS/ESC system at all. Do NOT replace an ABS/ESC unit without at least first applying the procedure described in this TSB. These symptoms may result from poor grounds at G19 and/or G20, caused by paint remains between the bolt and mating weld nut attaching the ground terminal to the body. This TSB provides a procedure to properly correct this condition. Remember too, that other poor connections may exist, and should also be checked prior to any part replacement.

Located Behind ABS/ESC Unit On LH (Driver's) Side Outboard Panel

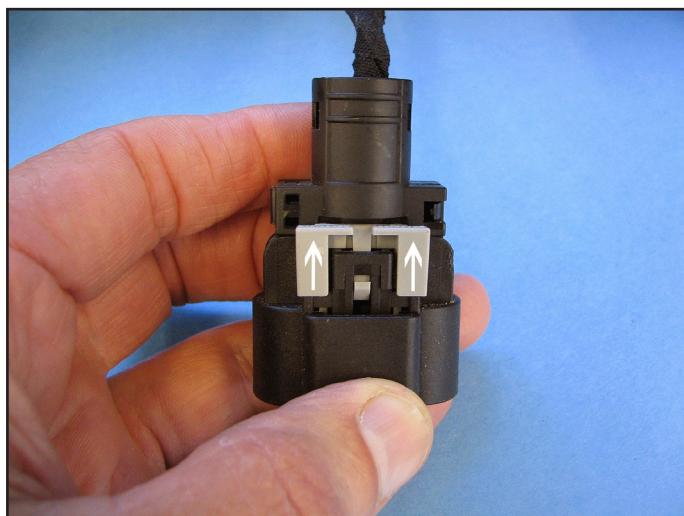
Gray lock tab is shown here in the released (outward) position.

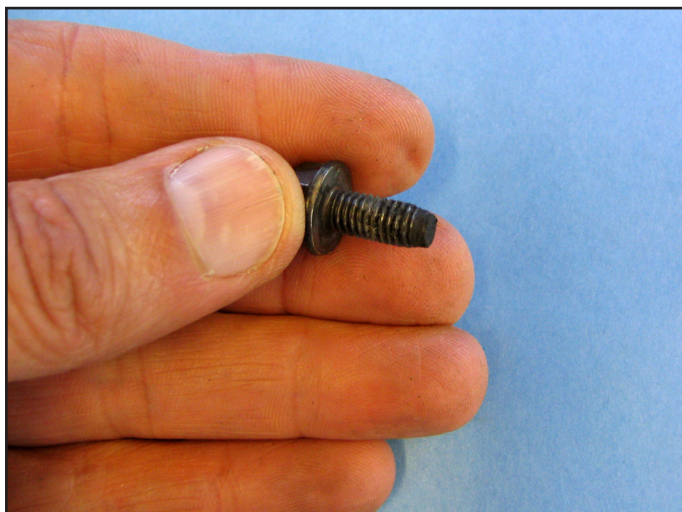
The bolt used for G19 – G20 is a self-tapping bolt, which collects debris when first inserted. The next steps will provide a procedure to clean and further remove any remaining debris from this bolt and its threaded hole.
