MODEL  
Optima (MS)  
Sportage (KM)

NUMBER  
038

## TECHNICAL SERVICE BULLETIN

2.5L/2.7L (DELTA) ENGINE HESITATION / MIL ILLUMINATION / P0123

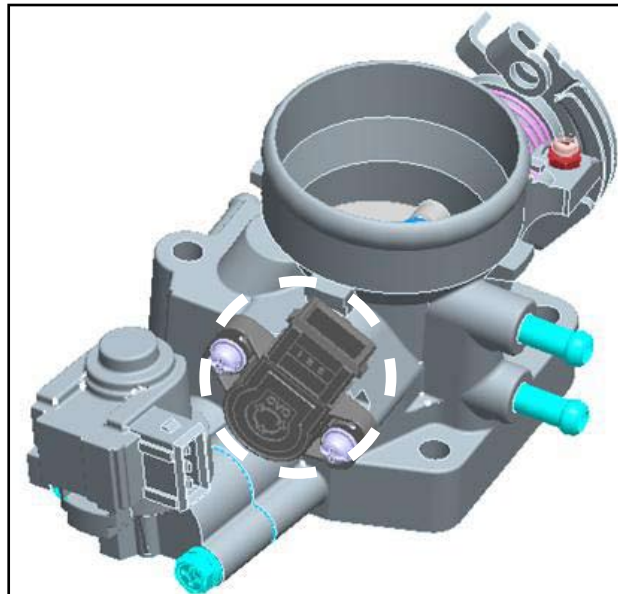
This bulletin provides information relating to an engine hesitation or the illumination of the Malfunction Indicator Lamp (MIL) for P0123 (Throttle Position Sensor / Switch "A" Circuit High Input).

Some 2001-2006 Optima (MS) produced between 10-07-2000 ~ 08-31-2005, equipped with the 2.5L or 2.7L (V-6) Delta Engine and some Sportage (KM) models produced between 10-28-2004 ~ 05/18/2007 equipped with the 2.7L (V-6) Delta Engine are applicable for this bulletin. Improper throttle position sensor values may cause the engine to hesitate under loads or cause the illumination of the MIL. To correct for this condition, the throttle position sensor (TPS) has been improved.

Part Number	
Previous	New
35170 37100	35170-37100FFF
