<b>VOLUME</b>  <b>3</b>	GROUP Climate Control	MODEL 2006-2008 Sedona
		NUMBER 010 (revised)	DATE August 2008
<b>TECHNICAL SERVICE BULLETIN</b>			
<b>SUBJECT:</b>  <b>A/C COMPRESSOR NOISE CONCERN</b>

## A/C COMPRESSOR NOISE CONCERN

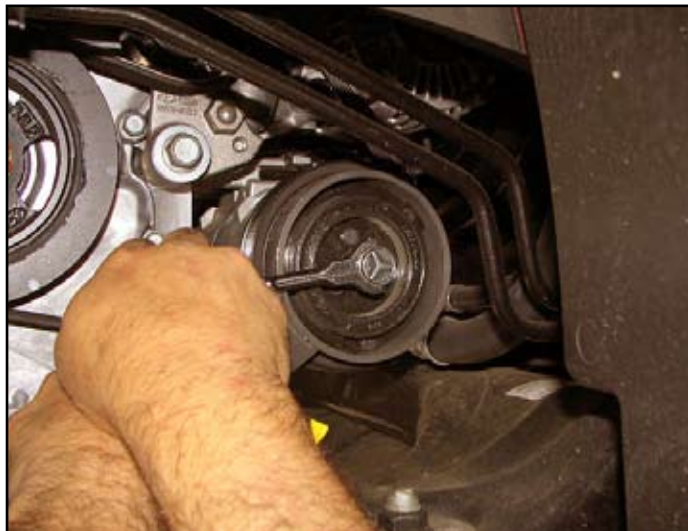
**Do NOT use power tools when removing or installing the disc + hub assembly bolt! Bolt is easily broken off if not properly removed and reinstalled!**

- Using hand tools, carefully remove the A/C compressors original disc + hub assembly.

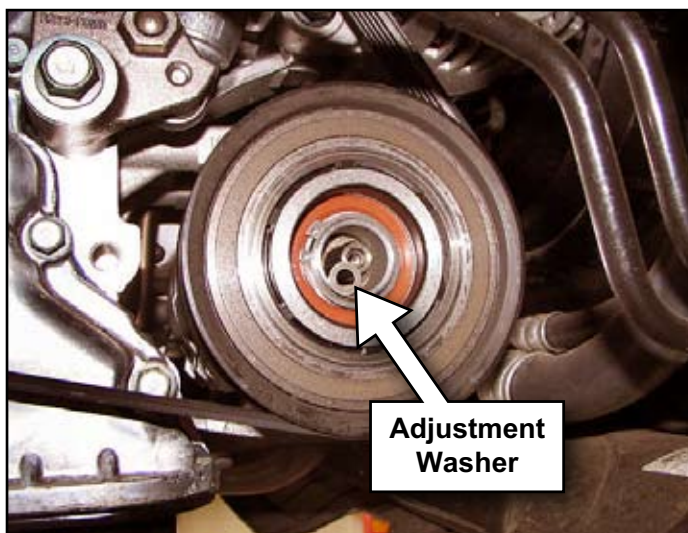
**An adjustment washer that is responsible for disc + hub to drive pulley clearance may stick to the end of the compressors shaft, stay inside the original hub assembly, or fall to the floor!**

**Take special care not to lose this washer!**

- Remove the disc + hub assembly by sliding it off the compressor shaft. No special tool or puller is required.

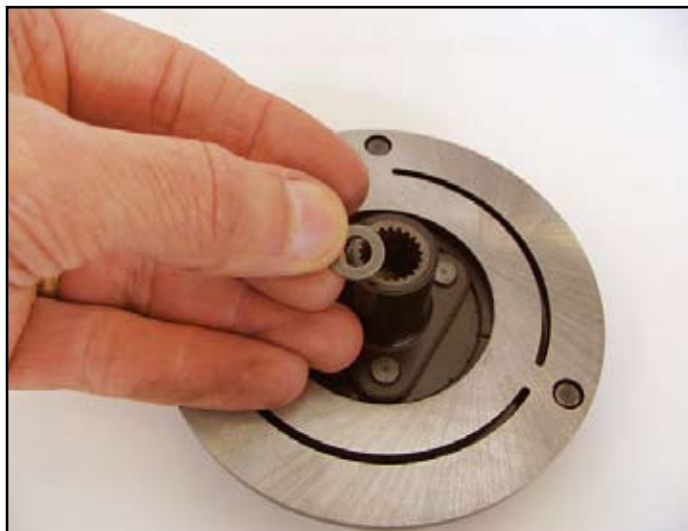
**Failure to transfer this adjustment washer from the original disc + hub assembly to the new assembly will cause the newly installed disc + hub assembly (and original pulley assembly) to fail!**

- Transfer the original disc + hub clearance adjustment washer to the new redesigned disc + hub assembly.

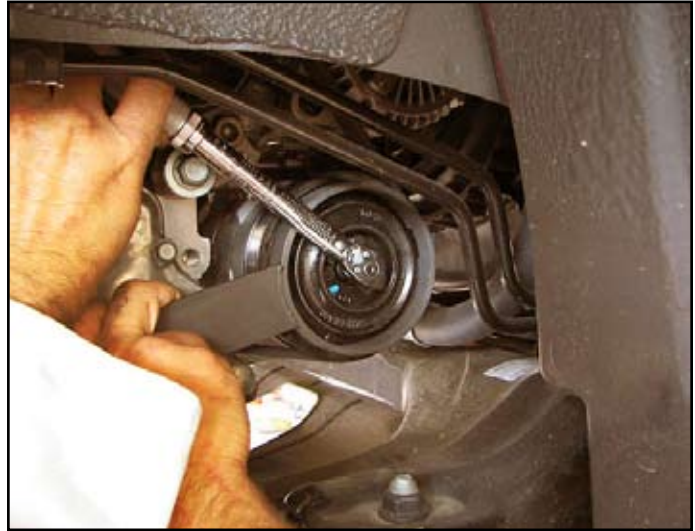
**Do NOT use power tools when installing the disc + hub assembly bolt! Bolt is easily broken off if not properly tightened to specification.**

2. Reinstall the new redesigned disc + hub assembly. Lightly tighten the assembly bolt using hand tools and SST 09977-29000. Finish tightening using a torque wrench set to 7.2 ~ 10.8 lb-ft (86.4 to 129.6 lb-in).
