**KIA MOTORS**

MODEL  
Sorento (XM),  
Optima (MG), Rio (JB)

NUMBER  
072

**SUBJECT:** TROUBLESHOOTING DTC B1447/B1448/B1764/B1767  
(AIRBAG WARNING LAMP ILLUMINATED) ON VEHICLES WITH  
ELECTRIC FIELD OCCUPANT CLASSIFICATION SENSOR

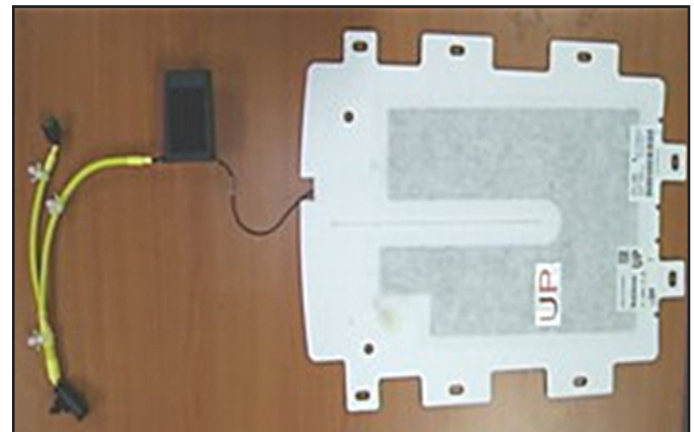
The purpose of this TSB is to ensure a proper response to the appearance of certain DTC codes that identify a certain temporary condition. On these vehicles, the occupant detection and classification system uses an **electric field sensor** instead of a pressure sensor. The customer is advised in the Owner's Manual not to place any electronic device on or near the seat cushion because it can defeat the OCS. **The electric field sensor is sensitive to interference from certain electronic devices, and is also sensitive to the seat getting wet.**

*Models described in this TSB:  
Electric field sensor*

1. Verify that the seat cushion is completely dry.
2. Verify that nearby electronic devices are turned off.
3. Clear DTC(s).
4. If DTC(s) do not re-code after this, review the above information with the customer. Do not attempt to make a repair.
5. If DTC(s) do re-code after this, proceed with diagnosis according to Service Information on KGIS.
