MODEL
Optima
(TF/QF/HEV)
2011/13MY

NUMBER
039

TECHNICAL SERVICE BULLETIN

CAUTION DURING REAR UPPER ARM SERVICE

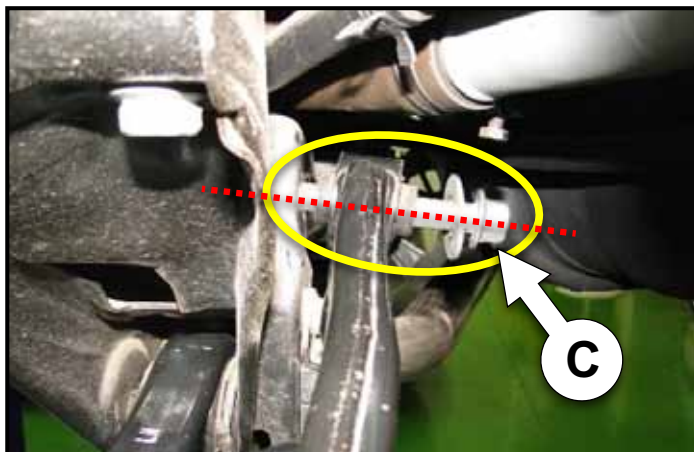
If the bolt is tightened without properly supporting the rear lower arm, the bolt to the subframe may be on a slanted axis (C) as shown in the photo on the right.

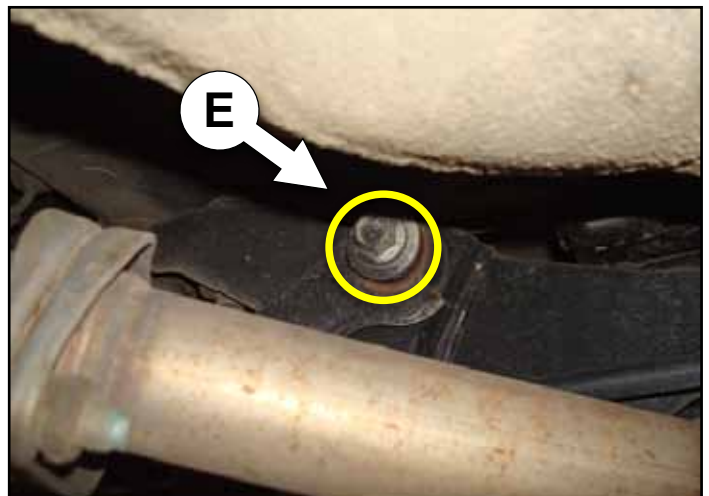
Tightening the bolt without properly aligning the bolt holes of rear upper arm and subframe (horizontally), the bolt (E) securing the rear upper arm to the subframe may become loose, and as a result, rust and noise concerns may occur later on.

4. The rear wheel alignment should be checked after performing this procedure.
