MODEL
2013MY Forte
Koup (TD)

NUMBER
040

TECHNICAL SERVICE BULLETIN

SUBJECT: SERVICE ACTION: FORTE KOUP AUDIO SOFTWARE UPGRADE (SA135)

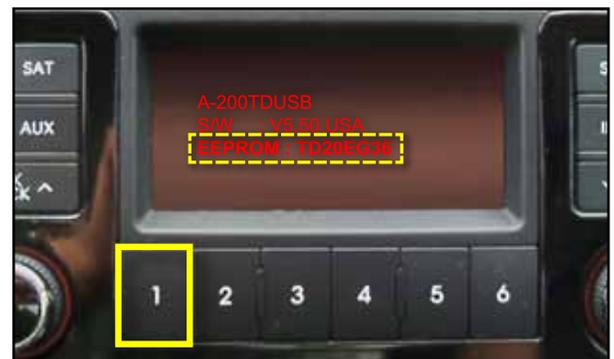
Check original EEPROM version (TD20EG36).

14. When software version screen is displayed, press **Preset Button 1**.

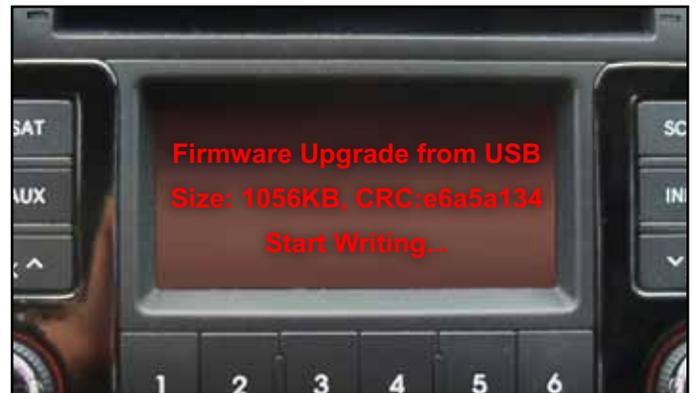
Micom software will take approximately 10 seconds to update. If the system prematurely reboots before 10 seconds have elapsed and power is OFF, the update may have failed. If this happens, repeat the update procedure from Step 1.

16. The update will proceed through Erasing→ Writing→Verify.

Once the update is complete, the system will automatically restart and power OFF.

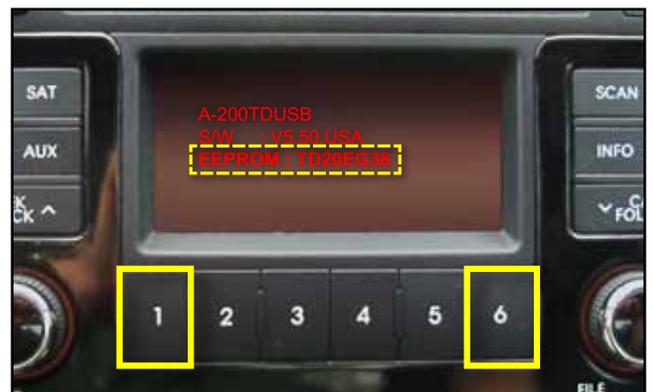
Confirm that new EEPROM version is (TD20EG38).

17. Power the system on and check the software version to confirm completion of update.

Press the **Preset Buttons 1 and 6** simultaneously for one second. The updated software version will be displayed on the screen as shown.
