GROUP BODY	MODEL Sorento (XMa) 2014MY
NUMBER 094	DATE March 2013

TECHNICAL SERVICE BULLETIN

SUBJECT: LIFTER BRACKET REPLACEMENT FOR SORENTO POWER TAILGATE SYSTEM

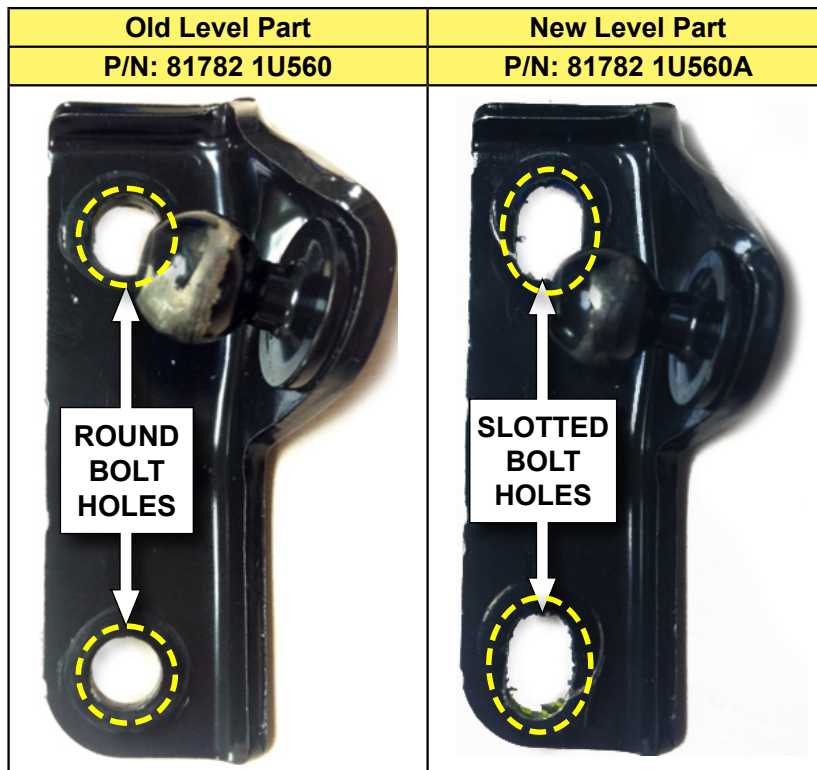
This bulletin provides the procedure to resolve a concern with the operation of the Power Tailgate System (PTGS) on some Sorento vehicles, produced from S.O.P. to February 26th, 2013. The concern occurs when the customer attempts to close the power tailgate from the fully open position. The tailgate may start to close but will stop and beep three times, signaling an error in the PTGS. The procedure outlined in this TSB only applies to the situation described above. Any other concerns relating to the PTGS should be diagnosed and repaired using the service information provided on KGIS.
