GROUP Electrical	MODEL 2014MY Sorento (XMa) w/IMS Seats
	NUMBER ELE 069	DATE September 2014

TECHNICAL SERVICE BULLETIN

SUBJECT: DRIVER'S SIDE POWER WINDOW SWITCH REPLACEMENT

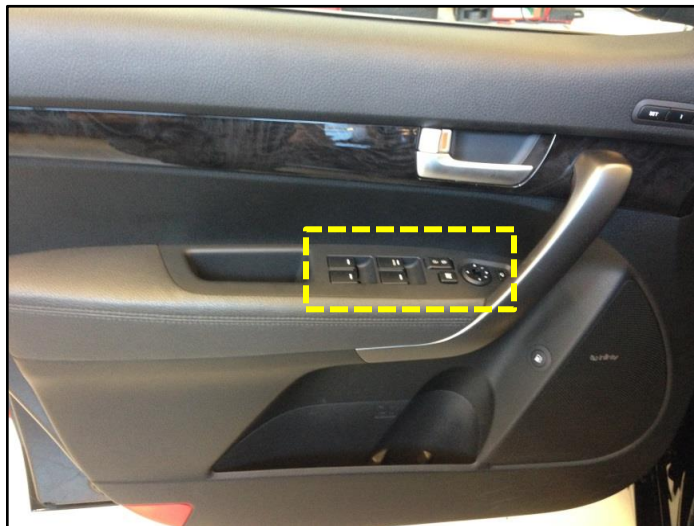
Master Power Window Switch

This bulletin provides the procedure to replace the window motor switch of some 2014MY Sorento (XMa) vehicles, produced from December 17, 2012 through December 13, 2013, which may exhibit an intermittent parasitic draw concern. Before conducting this repair, verify that TSB ELE057/SA163 - IPM Logic Improvement - has been performed on the vehicle. **This procedure applies ONLY to vehicles equipped with Integrated Memory System (IMS) Seats.**
