NUMBER: 23-006-07

Buzz/Rattle Like Sound In Rear Quarter Panel Speaker Area With or Without The Radio On

2005 - 2007 (RS) Town & Country/Caravan

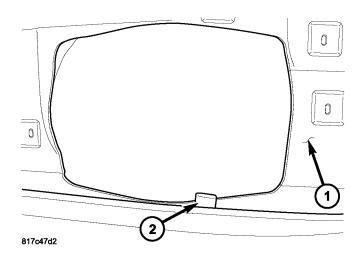
Fig. 1 TAB ON QUARTER TRIM PANEL

This bulletin involves cutting a tab off of the rear quarter trim panel so that the tab cannot contact the rear speaker grille on both sides of the vehicle.

Buzz/Rattle like sound in the rear guarter panel speaker area with or without the radio on.

- Remove the left quarter trim bolster over the speaker. Refer to the detailed service information available in TechCONNECT, under: Service Info, 23 -Body/Interior/Quarter Trim Bolster - Removal.
- 2. Locate the tab on the quarter trim panel. Cut the tab off of the trim panel so that it cannot contact the speaker grille (Fig. 1).

- 1 REAR QUARTER TRIM PANEL
- 2 TAB TO BE CUT OFF
- Install the rear quarter trim bolster over the speaker.
 Repeat Step #1 through Step #3 on the right side of the vehicle.
