NUMBER: 23-008-16

Squeak Noise Coming From Rear Cargo Area

This bulletin involves installing rivets to the left and right rear quarter trim panel support brackets.

2015 - 2016	(BU)	Jeep Renegade
2016	(B1)	Jeep Renegade (LATAM)

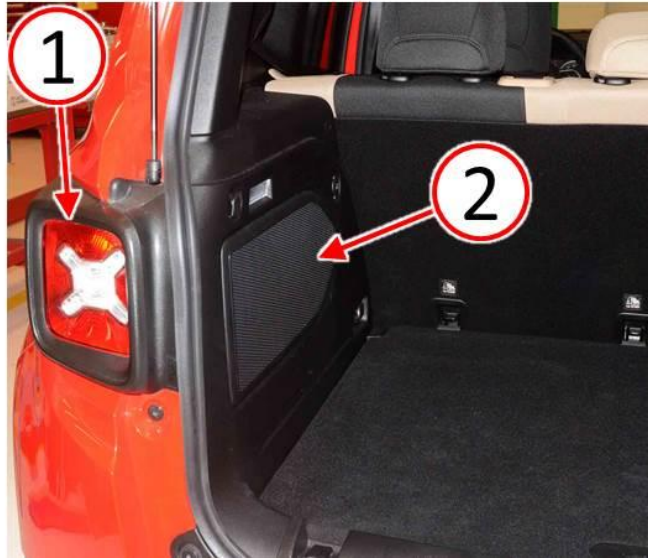
Fig. 1 Tail Lamps And Trim Panels

- 1 - Left Tail Lamp
 - 2 - Quarter Trim Panel
-

1. Remove the left and right tail lamps (1) (Fig. 1). Refer to the detailed service procedures available in DealerCONNECT> TechCONNECT under: Service Info> 08 - Electrical> 8L - Lamps and Lighting> Lamps/Lighting - Exterior> Lamp, Tail> Removal and Installation.
2. Remove the left and right rear quarter trim panels (2) (Fig. 1).

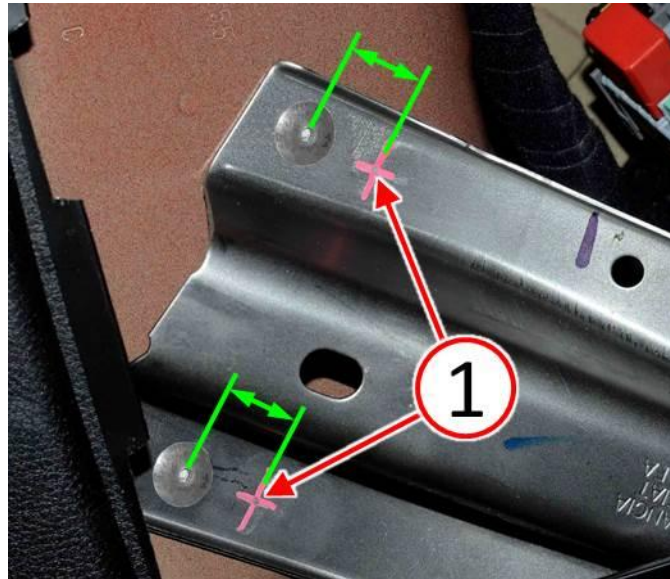
Fig. 2 Measure Mark And Center Punch Rivet Hole Locations

1 - Hole Locations

3. Measure, mark and center punch new hole locations (1) approximately 22 mm (.86 in.) from the previous rivets as shown in (Fig. 2). Perform this step for both the left and right rear quarter trim panel support brackets.

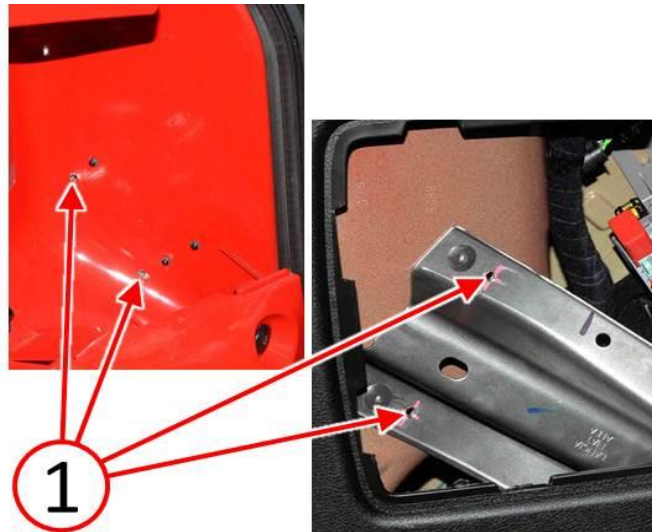
Fig. 3 Drill Two Rivet Holes Through Each Support Bracket

1 - Holes

-
4. Using a drill and a 5 mm drill bit, drill 2 new holes (1) through each support bracket and tail lamp bucket at the previously marked locations (Fig. 3). Perform this step for both the left and right rear quarter trim panel support brackets.
 5. Remove all burrs from the holes (1) and clean away any metal shavings from vehicle interior and from the tail lamp bucket (Fig. 3). Perform this step for both the left and right rear quarter trim panel support brackets.
 6. **Apply a corrosion-preventor primer (3M Single Step Primer) or equivalent over holes (1) (Fig. 3). Allow the primer to dry for approximately 10 minutes at a temperature of 60-70°C (140°-158°F).**

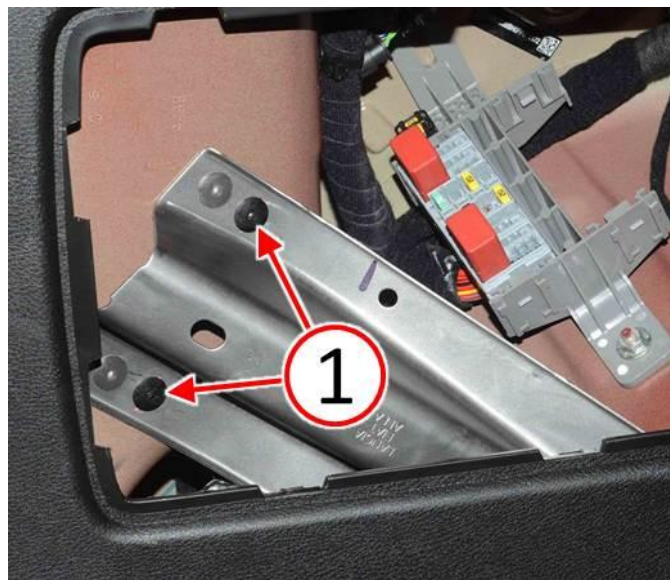
Fig. 4 Secure Rivets In Drilled Holes

1 - Rivets

7. Using a suitable rivet installation tool, secure the four steel rivets (1) into the four drilled holes (Fig. 4).

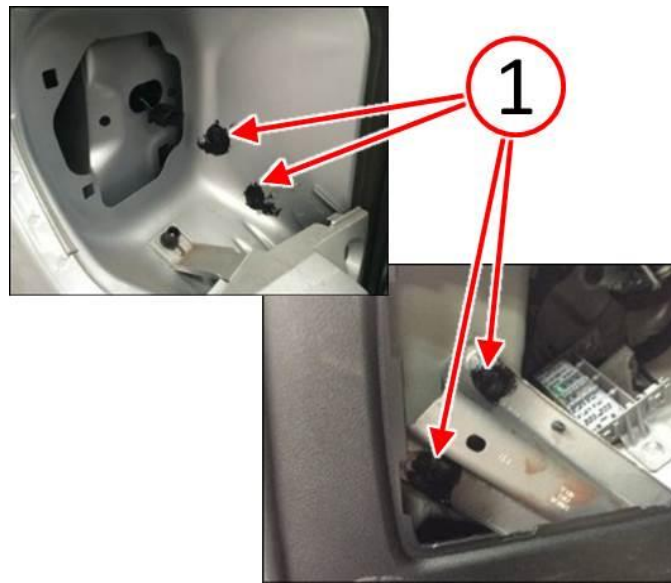
Fig. 5 Cover Rivets With Polyurethane Adhesive Sealant

1 - Polyurethane Adhesive Sealant

8. Using polyurethane adhesive sealant or Mopar weather strip adhesive, completely cover and seal the rivets on both sides (inside the vehicle and inside the tail lamp bucket) in order to fully encapsulate the rivets to protect against water infiltration ([Fig. 5](#)).

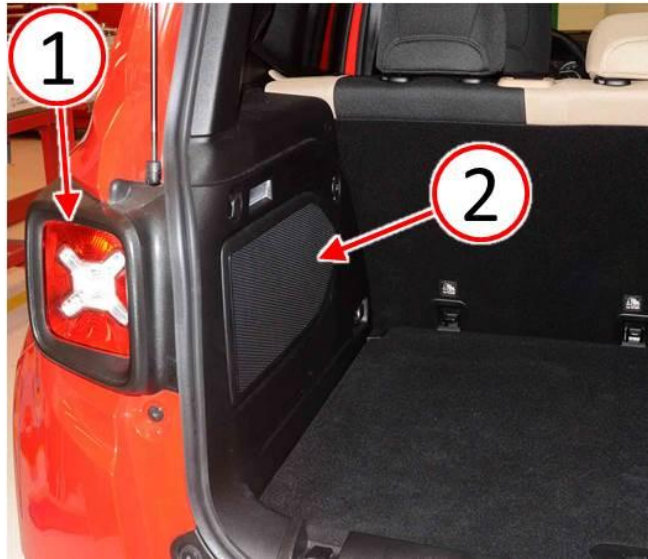
Fig. 6 Tail Lamps And Trim Panels

- 1 - Left Tail Lamp
- 2 - Quarter Trim Panel

-
9. Install the left and right tail lamps (1) ([Fig. 6](#)). Refer to the detailed service procedures available in DealerCONNECT> TechCONNECT under: Service Info> 08 - Electrical> 8L - Lamps and Lighting> Lamps/Lighting - Exterior> Lamp, Tail> Removal and Installation.
 10. Install the left and right rear quarter trim panels (2) ([Fig. 6](#)).
