NUMBER: 23-023-15 REV. A

Wind Noise Dual Pane Sunroof

This bulletin involves inserting a foam stuffer into the sunroof bulb seal.

2015 (UF) Chrysler 200

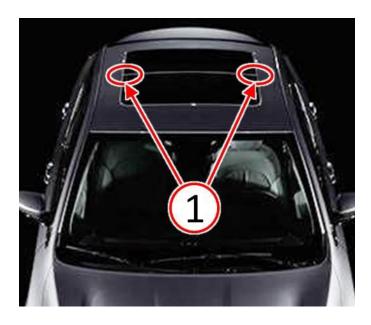
Fig. 1 Inspection Locations

1 - Inspect Right And Left Side

1. With the sunroof closed, inspect the sunroof fixed pane bulb seal in relation to the movable pane on both the right and left side of the vehicle (Fig. 1) and (Fig. 2).

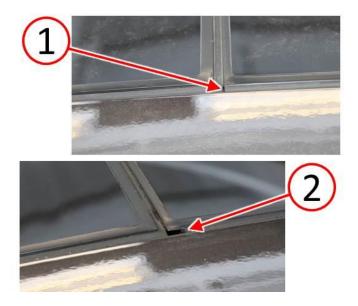
Fig. 2 Gap Inspection

- 2. Is the distance between the fixed pane bulb seal and the movable sunroof pane greater than 1 mm? (Fig. 2)
 - a. Greater than 1 mm >>> Continue with the Repair Procedure Step #3.
 - b. Less than 1 mm >>> This bulletin has been completed, use LOP (23-51-72-90) to close the active RRT.

- 1 Acceptable Less Than 1 mm
- 2 Not Acceptable Greater Than 1 mm
- 3. Open the sunroof movable pane (1) and protect the front seat with a clean cover (2) (Fig. 3).
