**NUMBER:** 23-044-15

Poor Wheel Opening Molding Adhesion To The Body

2015	(DS)	Ram 1500 Pickup
2015	(DJ)	Ram 2500 Pickup

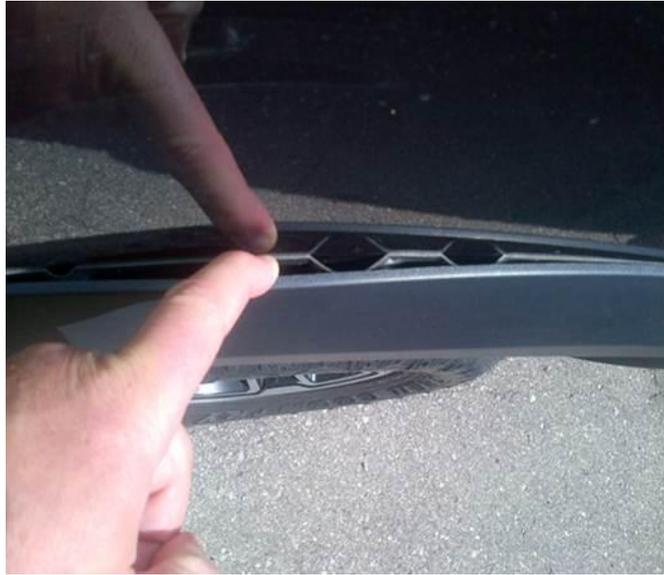
Wheel opening moldings may separate at body due to insufficient adhesive bond strength (Fig. 1).

**Fig. 1 Wheel opening molding separation**

1. If wheel opening molding separation is visible at the body, the affected wheel opening molding will need to be replaced.
2. Was any seam separation found at the wheel opening moldings?
  - a. YES>>> Replace the affected wheel opening molding as require if signs of separation are shown. Refer to 23 - Body/Exterior/MOLDING,Wheel Opening/Removal/Installation for the applicable Front or Rear Replacement Procedure(s).
  - b. NO>>> Wheel opening molding separation was not found. This bulletin has been completed. Use LOP (23-02-60-91) to close the active RRT.
