NUMBER: 23-049-15

Decklid Contacts The Body Side Aperture Above The Stop Lamp

2016 (LD) Dodge Charger

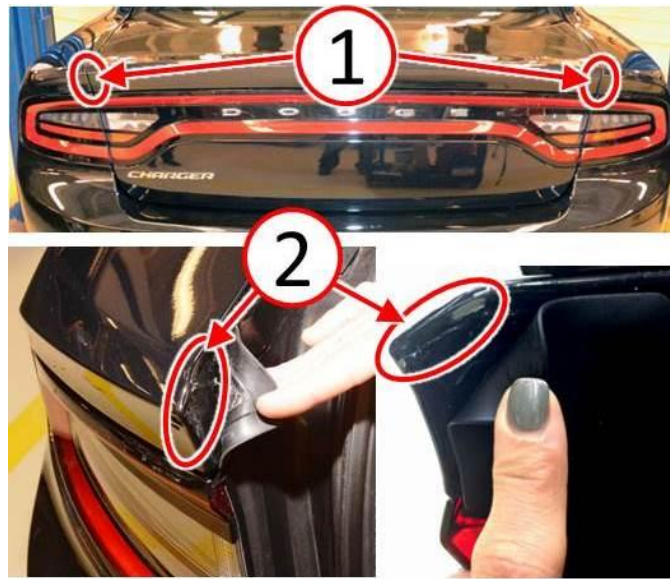
Fig. 1 Contact Areas And Chipped Paint

The customer may describe contact between the decklid and body side aperture (1) and/or chipped paint (2) on left or right side above the stop lamp (Fig. 1).

1 - Decklid To Body Side Aperture Contact

2 - Chipped Paint

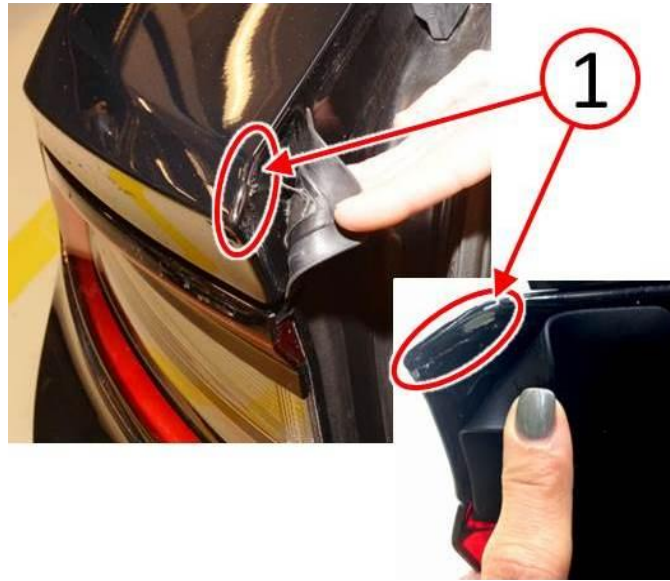
Fig. 9 Touch Up Paint Chips

1 - Paint Chips

22. If paint was chipped due to contact between the decklid and body side aperture, touch up the paint as required.
