**NUMBER:** 23-050-15

Water Entering Passenger Side Windshield Area

2016 (DS) Ram 1500 Pick Up

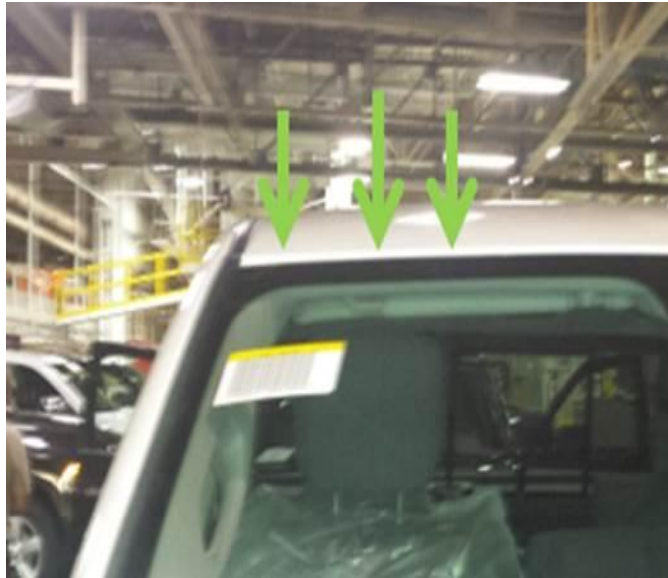
**Fig. 1 Water Test Leak Location**

The customer may experience wet carpet in the right front footwell. This condition may be due to a sealant void between the windshield and the roof pillar.

1. Test vehicle by using a water hose and directing the water stream (high volume medium pressure) to the area identified for 2 minutes (Fig. 1).

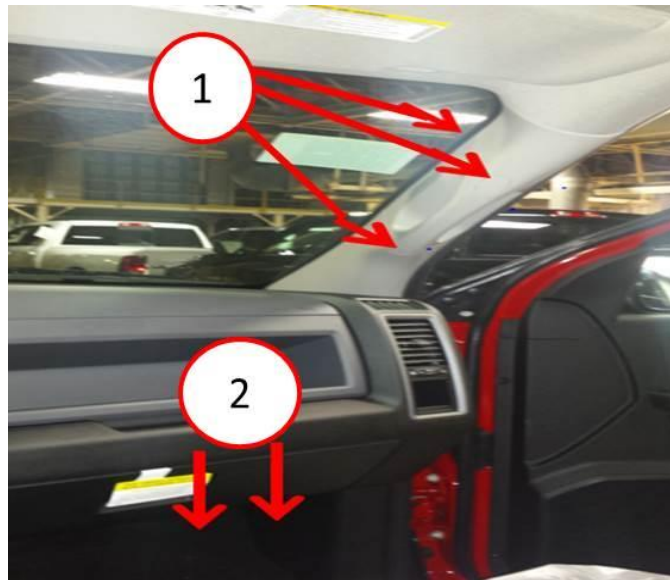
**Fig. 2 Potential Leak Areas**

2. Inspect critical areas (1) and (2) identified inside the vehicle for any water residue or leakage (Fig. 2). Inspect behind carpet insulation at bulkhead at the forward most edge of the carpet. Is water leaking inside the vehicle while performing the water leak test?

4. Inspect for any trace of water coming from the windshield suspected areas or appearing in the right front footwell (Fig. 2).
  - a. If no water is found entering the vehicle interior during the water test then the sealant process is complete.

- 1 - A-Pillar
- 2 - Passenger Foot Well

- a. YES>>> Water is entering the vehicle. Remove the passenger side windshield molding. Refer to 23 - Body/Weatherstrip/Seals/Weatherstrip, Windshield - Removal. Identify leak location by using an air hose on the outside edge of the windshield and repair with Kent® Hi-Tech Clear Seam Sealer or Equivalent. Continue to [Step #3](#).

- 
5. Reinstall the passenger side windshield molding. Refer to 23 - Body/Weatherstrip/Seals/Weatherstrip, Windshield - Installation.
