Applies To: **See VEHICLES AFFECTED**
**November 23, 2011**

## Engine Knocks or Ticks at Idle

(Supersedes 08-017, dated February 11, 2011, to revise the information marked by the black bars)

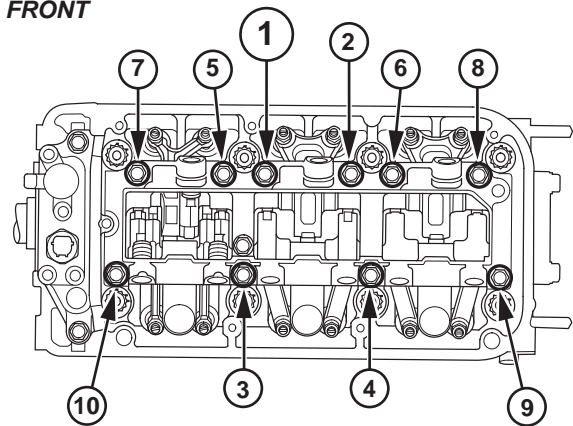
### FRONT

The rocker shaft bridge has excessive clearance which causes the rocker shaft to rotate and make noise.

2. On the front cylinder head, loosen and then torque each rocker shaft bridge bolt one at a time in the sequence shown below. Torque the bolts to **28 N•m (21 lb-ft)** to crush the bridge around the rocker shaft.

3. Loosen and then torque each rocker shaft bridge bolt again one at a time to **24.5 N•m (18 lb-ft)** in the sequence shown above for the front cylinder head.
