51398-02259 Version 2

Function Buttons (PHONE, MENU, BACK, SETTINGS, Etc.) Stick

Supersedes 14-022, dated May 21, 2014, to revise the information highlighted in yellow.

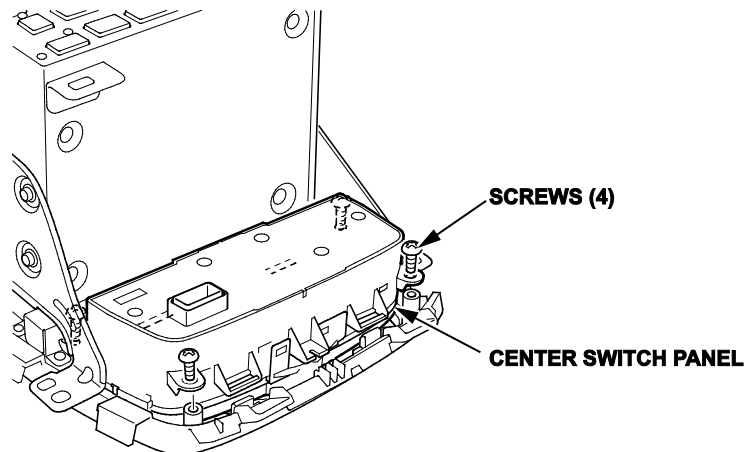
The center switch panel is deformed or is not centered in the audio unit panel.

1. Loosen the center switch panel screws, center the switch and retighten the screws. Make sure the switch is centered in the audio or audio-navigation unit panel opening and the buttons are no longer sticking.
