ATB51817 REV-1 (1407)

Buzz or Static Heard at Other End During HFL Call

Supersedes 14-029, dated July 03, 2014, to revise the information highlighted in yellow.

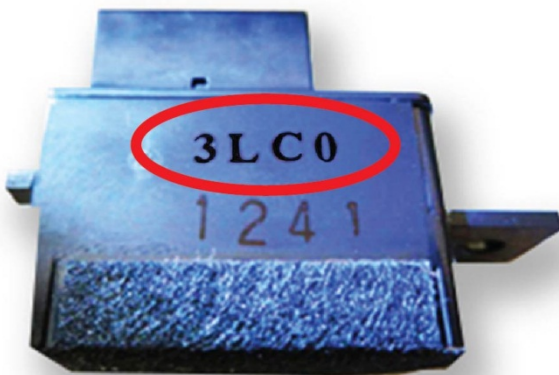
REVISED ILLUSTRATION

8. Inspect the side of the microphone unit. There will be two lines of numbers. The first two characters of the top line is a date code (circled below).

The unit shown in the picture above has a date code 3L, which translates into '2013 December'.

- Microphones with **date code 3J (2013 October) or after** have the updated design. If the vehicle already contains an updated microphone, do not replace it. Instead, proceed with normal troubleshooting.
- If the microphone has a date code that is before 3J, replace it with a new service part.
