Service Bulletin

14-030

June 18, 2014 ATB 51276-51801 REV1 (1406)

Slapping or Clicking From Engine Area at Idle

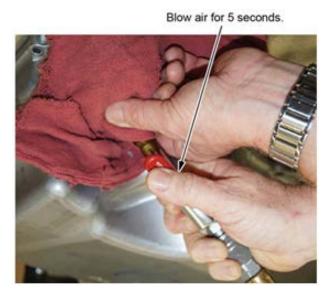
Debris may be restricting oil flow to the cam chain auto-tensioner.

10. Blow compressed air for 5 seconds through the oil passage to clear any debris before installing the new cam chain auto-tensioner.
