Service Bulletin

14-047

Noise From the Rear Differential

Year	Model	Trim	VIN Range
2012-14	CR-V	AWD Only	ALL

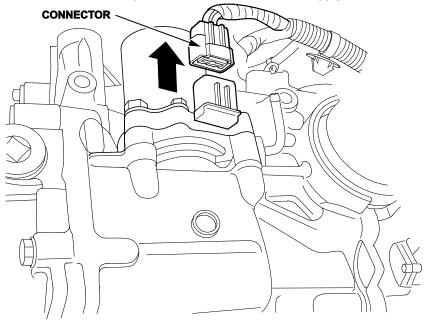
- 1. Raise the vehicle on a lift, then disconnect the rear differential oil pump motor 2P connector.
- 2. Lower the vehicle.
- 3. Start the vehicle. Apply the brake pedal, put the transmission in gear, and listen for the noise as soon as you release the brake.
 - If there is no noise, go to REPAIR PROCEDURE.
 - If the noise is still present, this bulletin does not apply. Continue with normal troubleshooting.
