00393-01725 Version 2

Rattle from the Tailgate Area on Rough Roads or Going over Bumps

Year	Model	Trim	VIN Range
2011–15	Odyssey	All with power tailgate	ALL

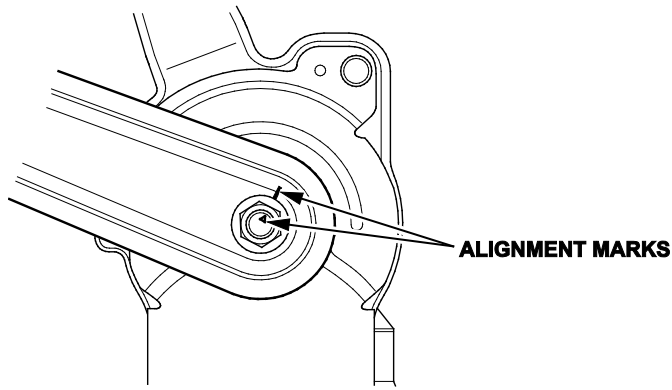
12. Note the alignment marks on the drive unit and the arm unit. Carefully remove the nut, and the arm unit.
