00317-01777 Version 4

Excessive Vibration Between 30 and 65 MPH

Supersedes 14-078, dated April 13, 2015, to revise the information highlighted in **yellow**

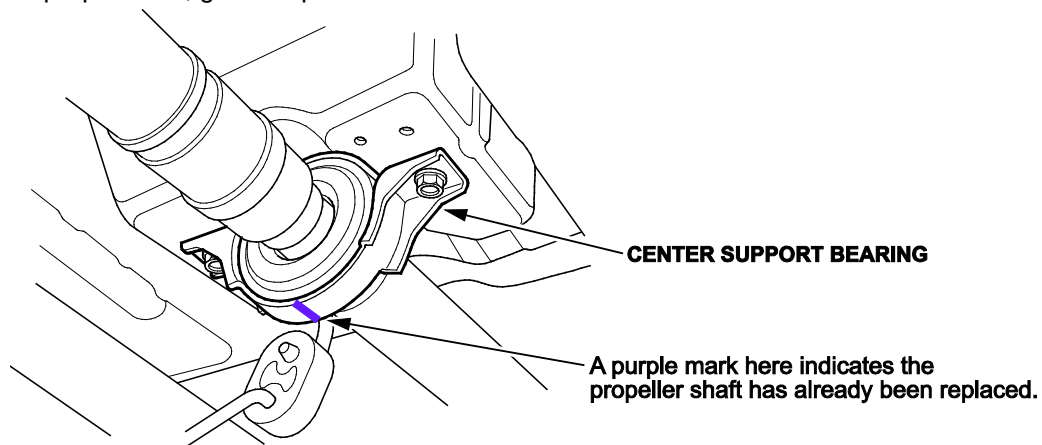
1. Raise and support the vehicle.
2. Check that the propeller shaft has not already been replaced. Check if there is a purple mark on the center support bearing as shown below.
 - If there is a purple mark on the center support bearing, the propeller shaft has already been replaced with a new part. Do not replace the propeller shaft again. If there is still a vibration, this bulletin does not apply. Continue with normal troubleshooting.
 - If there is no purple mark, go to step 3.
