May 15, 2015

01746 Version 1

Rubbing or Groaning from the Driver's Front Airbag Area

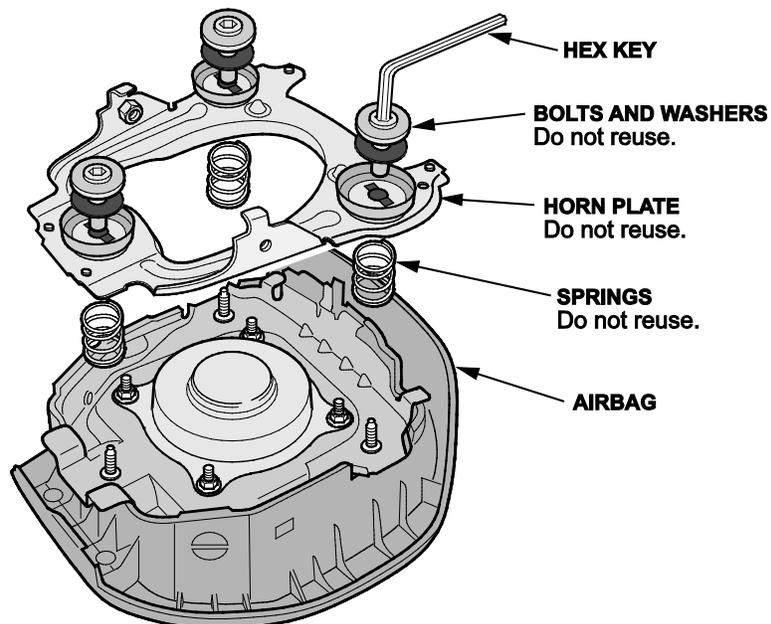
Noise is generated from moving parts/friction within the damper assemblies in the horn plate assembly.

7. Disconnect the horn switch connector.
8. Remove the driver's airbag.
9. Remove the three horn plate assembly bolts and washers and discard. Remove the three springs and discard.
