Model	Applicable To	File Under	Bulletin No.
1990 – 93 ACCORD	ALL	ENGINE	96-005
			Issue Date JAN 22, 1996

Excessive Idle Vibration or “Click” Sound

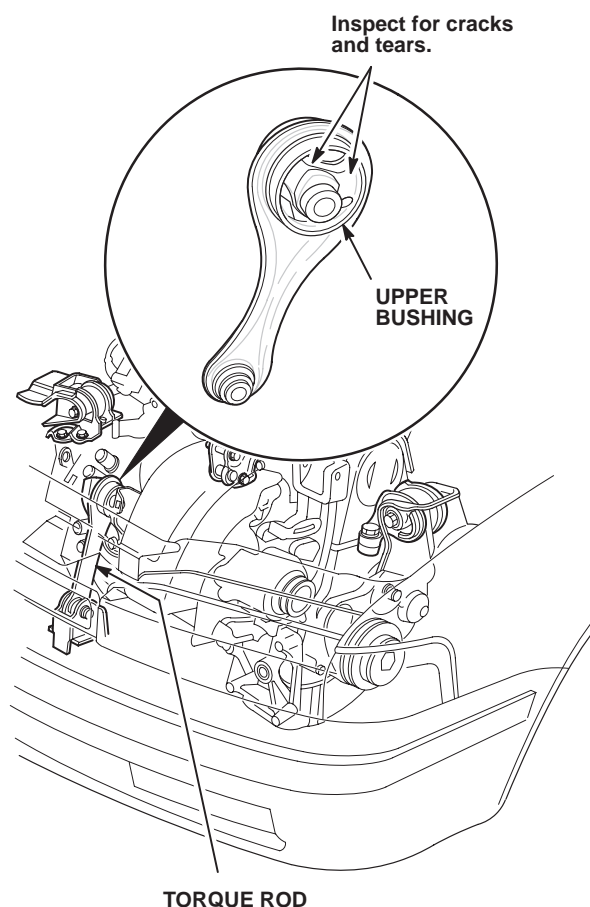
1. Inspect the torque rod upper bushing for cracks or tears. On A/T-equipped models, remove the upper mounting bolt and rotate the torque rod away from the engine.

- If the bushing is bad, continue to step 2 to replace the torque rod.
- If the bushing is OK, and the vehicle has an automatic transmission, go to **Diagnosis A**.
- If the bushing is OK, and the vehicle has a manual transmission, investigate other causes.
