**Technical Service
Information Bulletin**

A/C CONDENSER FAN RELAY CORROSION

'98 – '00 LX 470

HEATING & AIR CONDITIONING
AC002-00

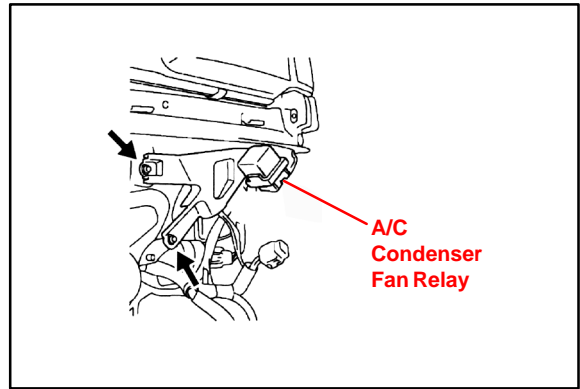
Introduction Some 1998 – 2000 model year LX 470 vehicles may have a condition in which the A/C condenser fan continues to run after the ignition is turned off due to corrosion in the relay connector. A repair kit (P/N 88840-60070) consisting of a new relay and sealant has been made available to correct this concern.

Repair Procedure**1. Remove A/C Condenser Fan Relay.**

- A. Disconnect the connector.
- B. Remove the two relay bracket retaining bolts.
- C. Remove the relay from the bracket.
