Inside Rearview Mirror Is Loose

(Supersedes 06-012, dated April 14, 2006, to revise the information marked by the black bars)

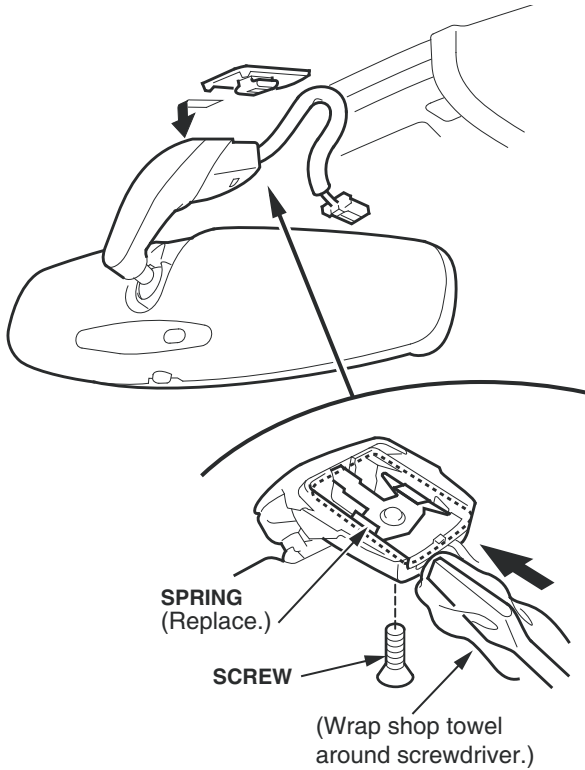
2. Remove the screw and the spring from the mirror bracket.

3. Install the new spring to the mirror bracket. The spring must be seated all the way down when you tighten the screw. Make sure the wiring harness is not pinched.
4. Reinstall the rearview mirror to the windshield.
 - Refer to the Body section of the appropriate service manual, or
 - Online, enter keyword **MIRROR**, and select **Automatic Dimming Rearview Mirror Replacement or Rearview Mirror Replacement** from the list.
