Windshield Washer Reservoir Leaks

(Supersedes 08-023, dated April 29, 2008, to revise the information marked by the black bars)

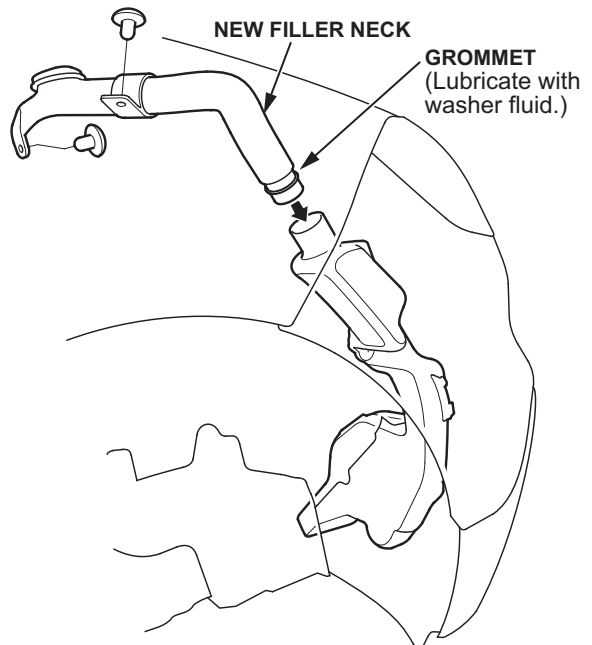
The orientation of the washer reservoir filler neck prevents the filler neck grommet from sealing the neck opening in the washer fluid reservoir.

- Lubricate the grommet with washer fluid, and install it on the new filler neck.
- Install the filler neck in the reservoir in the reverse order of removal.
