Applies To: 2002-06 RSX – ALL

February 10, 2010

Clunk and/or Vibration When Accelerating, Decelerating, or Shifting Gears

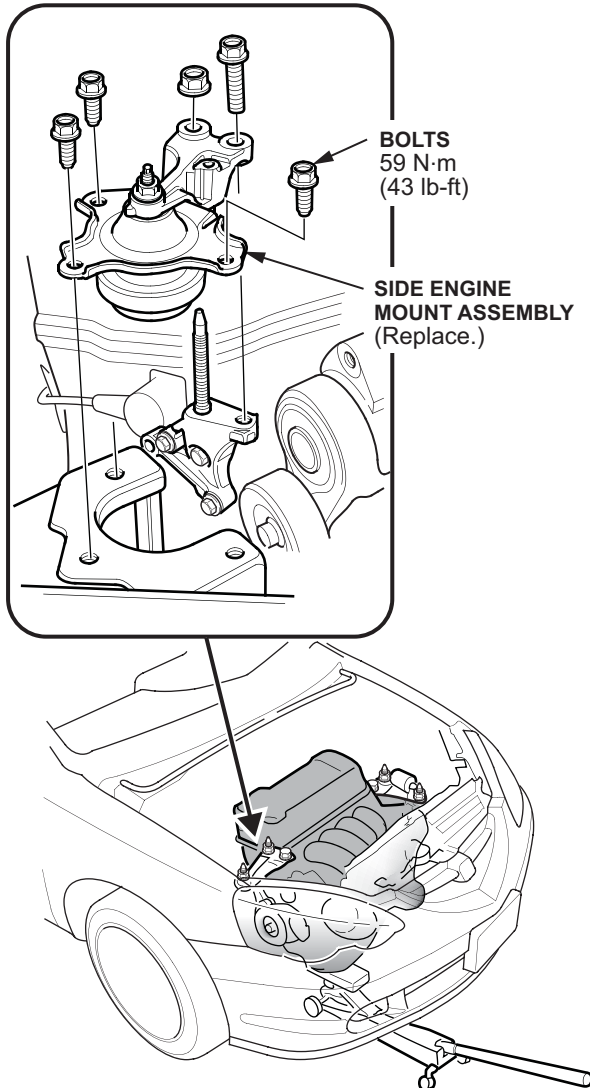
The side engine mount may have been misaligned, causing it to break.

8. While supporting the engine with a jack (making sure the engine is up against the mount), replace the side engine mount and its three mounting bolts.
