**2009–12 RL: Moisture in the Taillight**

(Supersedes 10-021, dated August 17, 2010, to revise the information marked by the black bars)

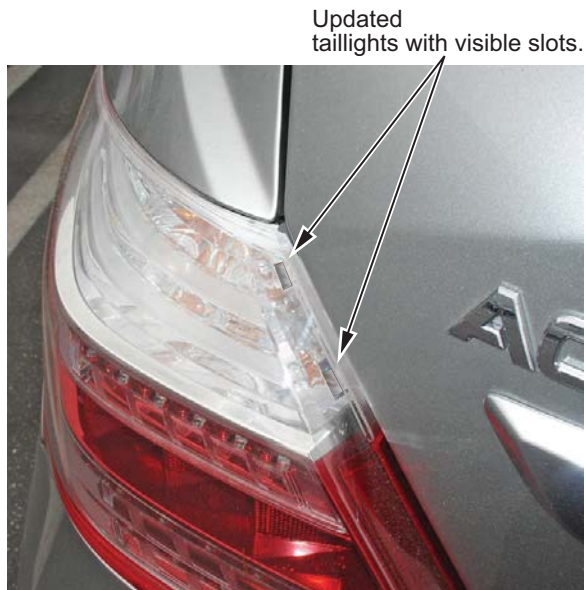
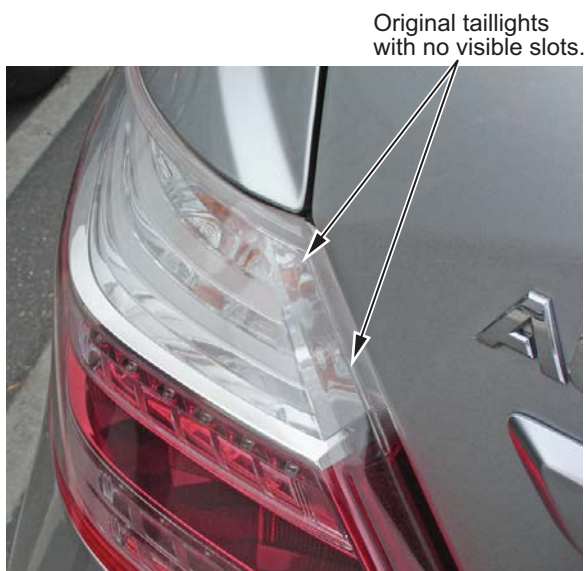
Moisture, fogging, or small water droplets are visible inside one or both taillights. and it does not dry up even after several days of dry weather.

High humidity plus insufficient ventilation causes condensation in the taillight(s).

1. Check the taillights to see if they been replaced with updated taillights (with slots).
 - If updated taillights are installed, go to REPAIR PROCEDURE, and install drain tube kits.
 - If the original style taillights are installed (no slots), go to REPAIR PROCEDURE, and replace the taillight(s).

Inspect the taillights, and replace them if they are not the updated type. If equipped with updated taillights, replace the taillight vent caps with drain tubes.
