Applies To: 2007–12 RDX – ALL  
2002–06 RSX – ALL

February 28, 2013

## MIL Comes On With DTC P2646 or P2647

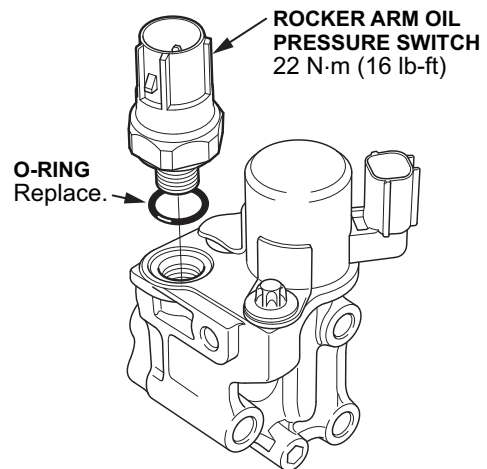
The rocker arm oil pressure switch may fail intermittently.

2. Remove the rocker arm oil pressure switch and the O-ring.

3. Install the new rocker arm oil pressure switch and the new O-ring. Torque the oil pressure switch to **22 N•m (16 lb-ft)**.
  - > Rocker arm oil pressure switch
  - > O-ring
4. Reinstall the power steering high pressure hose bracket.
5. Clear the code(s) with the HDS.
