BTB 00477 (1411)

## Buzzing or Static on Receiving End During HFL Call

### AFFECTED VEHICLES

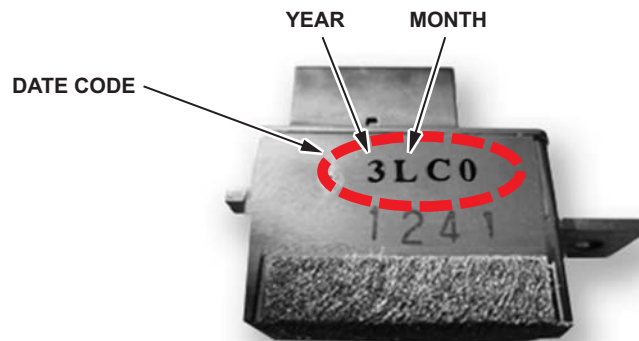
7. Inspect the side of the microphone. There will be two lines of numbers. The first two characters on the top line is the date code.

This microphone has a date code of **3L**, which means **2013 December**.

- If the microphone has a date code of **3J** (2013 October) or later, it has the updated design. Do not replace it. Instead, continue with normal troubleshooting.
- If the microphone has a date code earlier than **3J**, replace it with a new service part.
