SI B17 01 03  
Cooling Systems

September 2003  
Service Engineering

### Coolant Level Warning Light On

X5 with 4.4 and 4.6 liter engine from start of production to 4/20/03

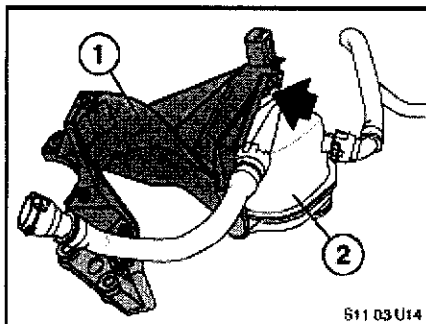
Insufficient clearance between underside of the coolant expansion tank (2) and the support bracket (1) as indicated by the arrow in illustration. Contact between the bracket and the coolant level sensor, located on the underside of the expansion tank, causes damage to the sensor which, in turn, leads to warning light illumination.

On a customer complaint basis and where there is evidence of sensor to bracket interference, replace the existing bracket with the new modified support bracket currently available through Parts. The part number remains the same as the original part. Additionally, replace the coolant level sensor.

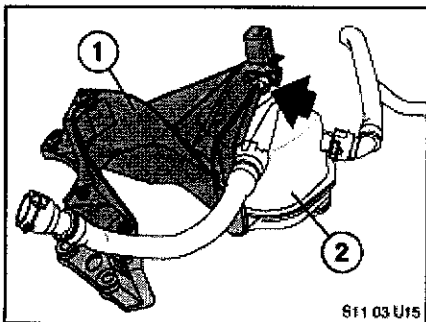
The new part has a cutout in the area of the coolant level sensor which eliminates the area of contact. Note area indicated by arrow.
