YEAR
1994 - 96

MODEL
INTEGRA

BULLETIN NO.
96-007

Air Conditioning Inoperative

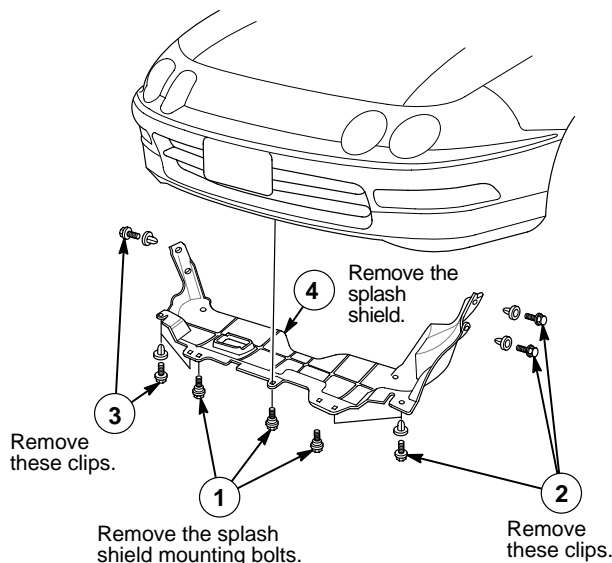
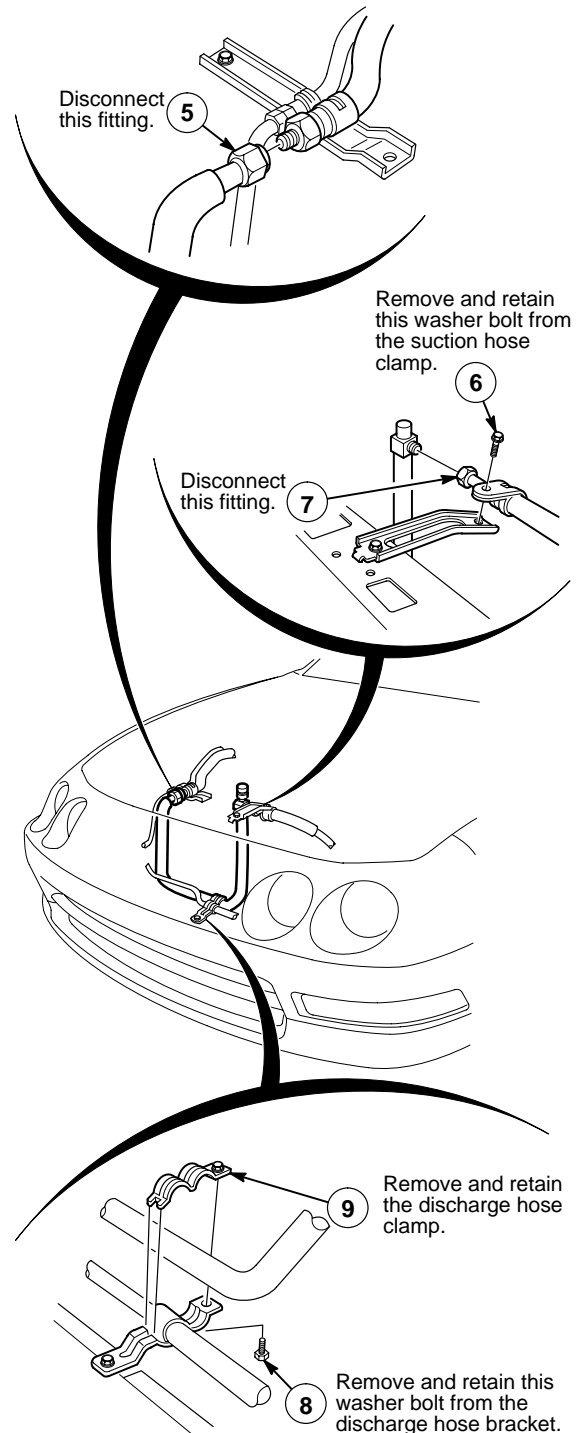
1. Recover any remaining refrigerant in the system, and inspect suction line A for a rubbed-through hole.
2. Remove suction line A.

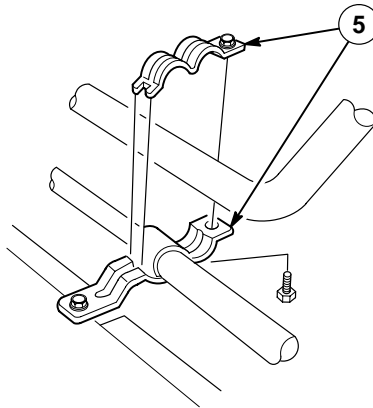
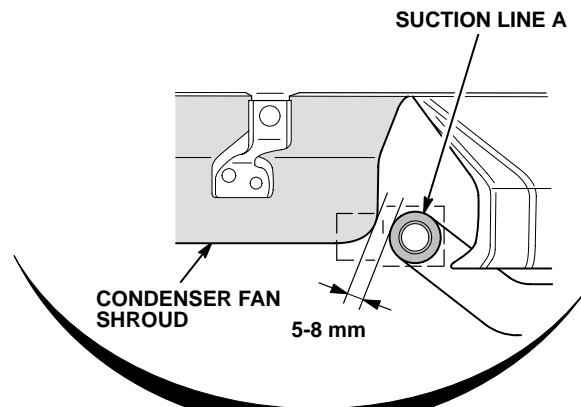
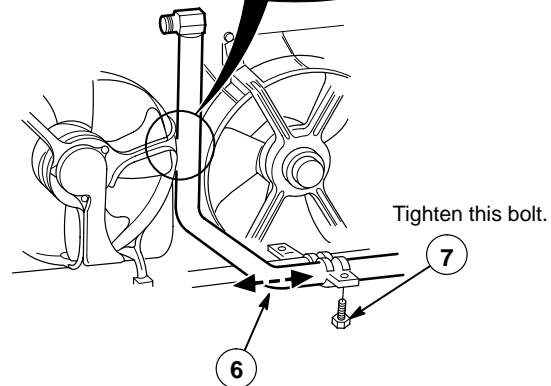
A hole is rubbed in suction line A by contact with the condenser fan shroud.

Adjust suction line A to obtain 5 to 8 mm of clearance between it and the condenser fan shroud.
