Applies To: 1999-00 3.2TL – ALL

February 28, 2000

ABS and TCS Indicators Come On With DTCs 28, 81 (TCS) and/or 52, 53, 54, 81 (ABS)
(Supersedes 98-037, *ABS and TCS Indicators Are On and TCS DTC 28 Is Set*, dated March 15, 1999)**SYMPTOM**

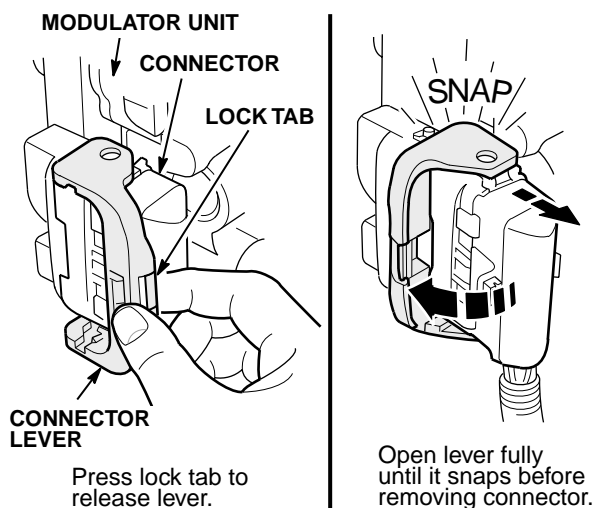
Water in the modulator unit connector.

3. Check the connector for water contamination.
 - If it is dry, follow the appropriate troubleshooting procedure on page 19-78 of the service manual.
 - If it is wet, go to step 4.
4. Use compressed air to dry the connector.
5. Apply a light coat of lithium dielectric grease to the connector face. Do *not* apply too much grease; it will push out the rubber seals in the back of the connector.
