# SERVICE BULLETIN

Classification:	Reference:	Date:
BT07-013	NTB07-065	September 13, 2007

## 2007 SENTRA; KNOCKING/METALLIC NOISE COMING FROM TRUNK AREA

**APPLIED VEHICLES:** 2007 Sentra (B16)  
**APPLIED VINS:** Vehicles built before: 3N1AB61E(\*)7L647021  
**APPLIED DATE:** Vehicles built before: December 13, 2006

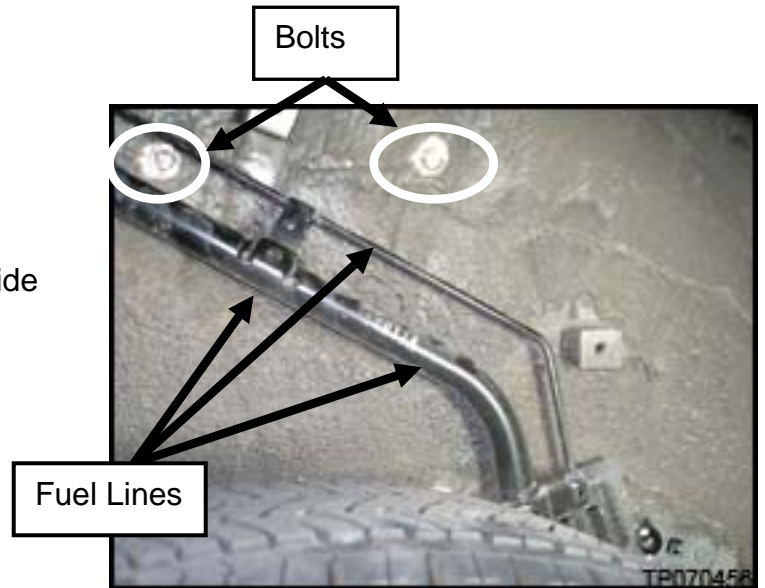
Figure 3

**CAUTION:** Make sure not to disturb the exposed fuel lines. See Figure 3.

- Repeat steps 1, 2, and 3 for the right side (see Figure 3).
