# SERVICE BULLETIN

Classification: BT99-055	Reference: NTB00-050	Date: June 8, 2000
-----------------------------	-------------------------	-----------------------

## 2000 FRONTIER CREW CAB DRONE NOISE AT 1,000 ENGINE RPM

**APPLIED VEHICLE:** 2000 Frontier (D22) Crew Cab - 2WD A/T ONLY

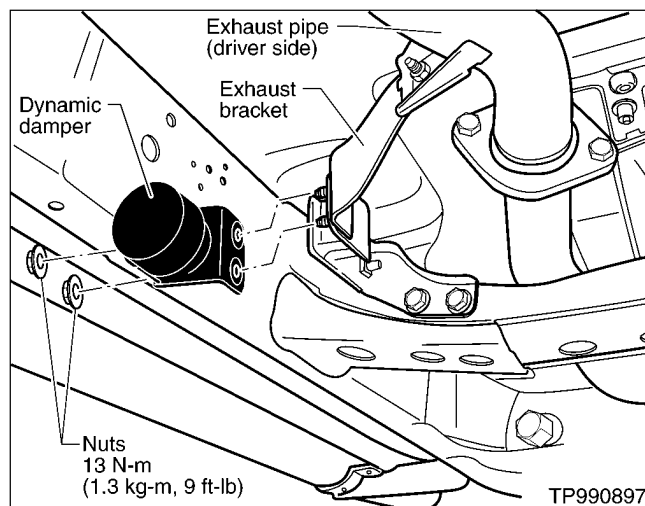
If a 2000 Frontier Crew Cab exhibits a drone noise inside the vehicle during warm-up as the engine speed slowly drops down through 1,000 RPM, use the service procedure listed below to resolve the incident.

Install the dynamic damper on the exhaust bracket and tighten the damper mounting nuts to 13 N-m (1.3 kg-m, 9 ft-lb). Refer to Figure 1 below.

**NOTE:** The nuts for mounting the damper are already on the vehicle (i.e., on the exhaust bracket).
