Technical Service BULLETIN

Title: 2UZ-FE ACCESSORY DRIVE BELT NOISE

Models: '00 - '06 Tundra

ENGINE
REVISÉD
EG026-06

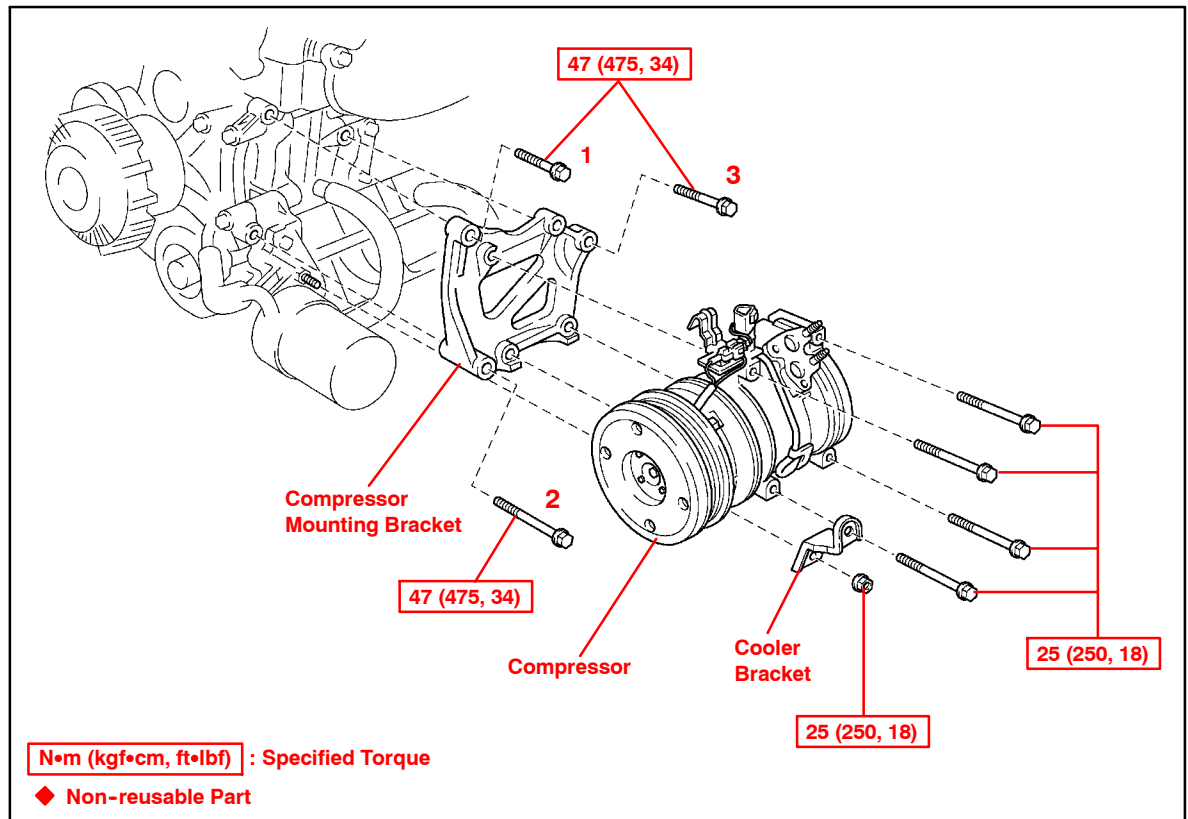
Introduction Some customers may experience an abnormal squeal noise from the engine accessory drive belt area, usually during cold start-up. An improved accessory drive belt tensioner, A/C compressor bracket, and revised installation procedure have been developed to address this condition.

11. Disconnect the A/C compressor mounting bracket.
12. Install the NEW A/C compressor mounting bracket and hand tighten bolts 1 and 2 while holding the bracket forward (refer to illustration below).
13. While holding the bracket forward, tighten the A/C compressor mounting bolts in the following sequence: bolt 2, bolt 1, bolt 3.

Torque: 47 N•m (475 kgf•cm, 34 ft•lbf)
