**Technical Service
BULLETIN**

**M.I.L. "ON" DTC P0171, P030#, AND/OR
P0133 ENGINE RUNNING LEAN IN
SUBFREEZING AMBIENT
TEMPERATURES**

'00 - '05 Celica (1ZZ-FE)

**ENGINE
EG046-07**

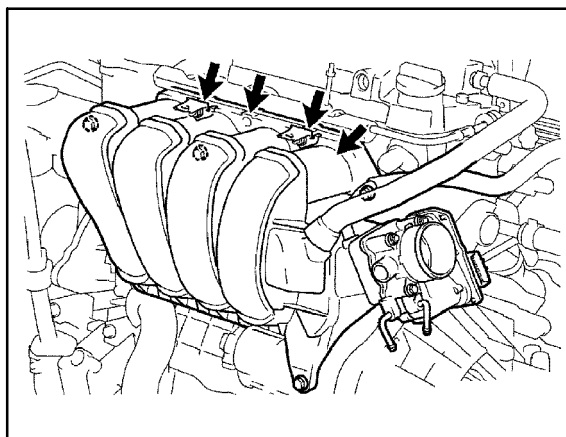
2. Following conventional diagnostic procedure, confirm if there is a leak where the intake manifold and cylinder head meet between each intake runner.

3. Did the short term fuel trim change to a rich reading (negative fuel trim) in step 2?
 - If **YES** — Replace the intake manifold gasket.
 - If **NO** — Check for other vacuum leaks or lean running conditions per the Technical Information System (TIS).
