# Technical Service BULLETIN

## Title: **EXTENDED ENGINE CRANK** Models: '04 Tacoma & Tundra

ENGINE  
EG052-04

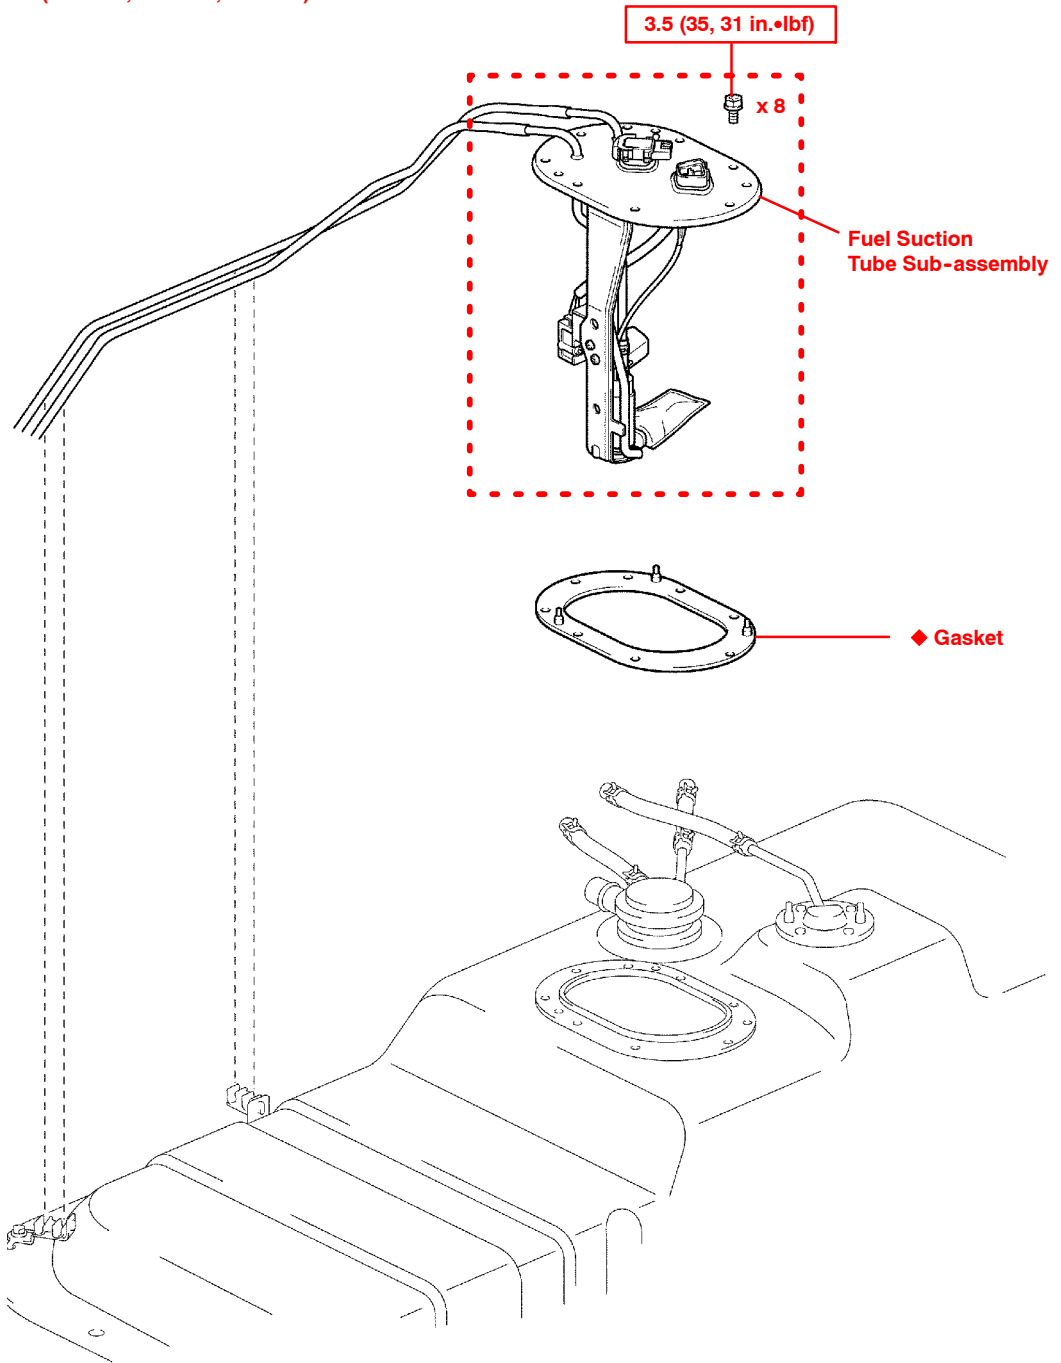
Parts  
Location:  
2004 Tacoma

**Please refer to Parts Location diagrams on pages 3 and 4 for location of Fuel Suction Tube Sub-assembly on 2004 Tacoma and Tundra.**

1. Confirm customer's complaint.
2. Check fuel pressure and residual fuel pressure.  
Refer to the Technical Information System (TIS), 2004 model year Tacoma Repair Manual: *SFI (2RZ-FE) or (3RZ-FE) or (5VZ-FE): Fuel Pump: On-Vehicle Inspection.*
3. If fuel pressure falls to zero after the engine is turned OFF, proceed to replace the Fuel Suction Tube Sub-assembly.  
Refer to TIS, 2004 model year Tacoma Repair Manual: *SFI (2RZ-FE) or (3RZ-FE) or (5VZ-FE): Fuel Pump: Removal.*
