**Technical Service
BULLETIN**

Title:
DOME LAMP FLICKERS OR STAYS ON
Models:
'01 – '02 Sequoia

ELECTRICAL
EL004-02

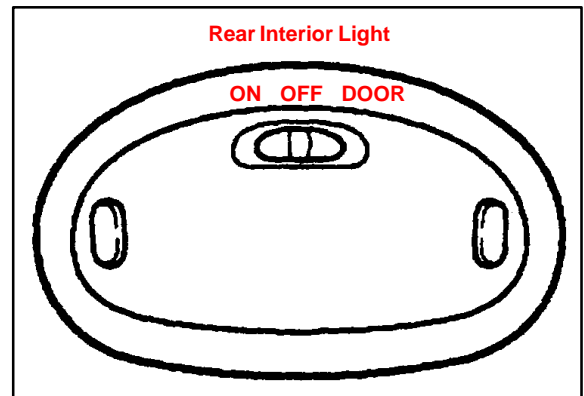
Introduction On some 2001 – 2002 model year Sequoia vehicles, the Rear Interior Light (Dome Light) may flicker or will not turn off. This usually occurs when the Dome Light switch is set in the “Door” position. The Dome Lamp Assembly has been improved to correct this condition.

Repair Procedure Replace the Dome Lamp Assembly with a countermeasure part.
