TECHNICAL BULLETIN  
JTB00346NAS1  
28 APR 2014

**SECTION: 501-00**

Transit Protection / Wrapguard Staining

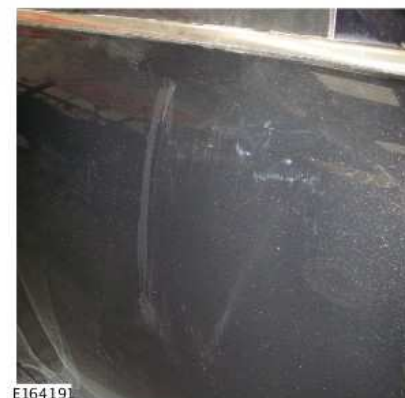
E164191

**Situation:** At Pre-Delivery Inspection (PDI) upon removal of the transit protection / wrapguard, there may be paint stains underneath the wrapguard. This staining can be described as 'bloom' or a 'milky' type of stain.

**Cause:** This may be caused by moisture being trapped under the transit protection / wrapguard. .

1. Fully remove the transit protection / wrapguard from the vehicle.
2. Inspect vehicle for 'bloom' or a 'milky' type of stain.

Subject the vehicle to a 30-minute bake cycle at 140°F / 60°C in a conventional spray booth.

- If a conventional spray booth is not available, apply localized heat from an infrared curing unit.

4. Once cool, polish the affected area.
