# TECHNICAL BULLETIN JTB00370NAS1 05 AUG 2014

# SECTION: 412-01

Condensation on Instrument Panel Center Vent

#### F-TYPE (X152)

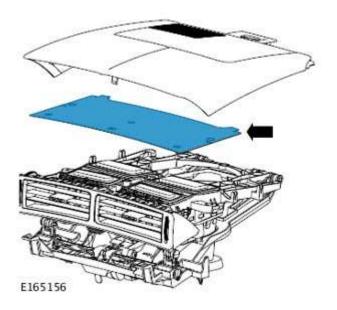
Situation: Condensation may be evident on the instrument panel center vent.

**Cause:** This may be caused by a difference in air/trim temperature, resulting in condensation forming on top of the instrument panel center vent.

2. Install the foam pad to the center vent.
