TECHNICAL BULLETIN

JTB00379NAS1
12 SEP 2014

SECTION: 417-00

Front / Rear Lamp Condensation - Information Only

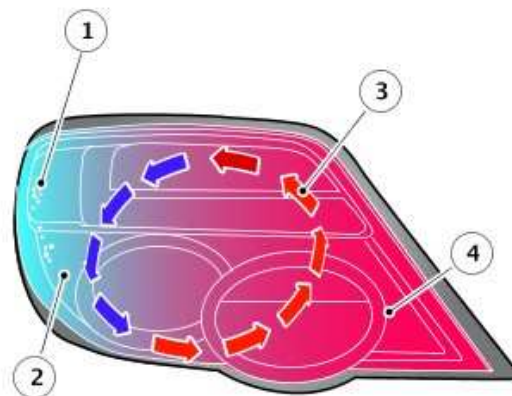
E170120

1. Condensation or moisture can be more noticeable during the months of spring and autumn when there is a likelihood of a higher moisture content in the air. It can occur when there is a temperature difference on either side of the lens surface. This can often be seen in the evening and morning sunshine or when cold water makes contact with a warm lamp lens. When a lamp is warmed unevenly by the sunshine the surface area in direct sunlight will be approximately 10°C higher than the remainder of the lamp. When warm air circulates within the lamp and makes contact with the colder surfaces moisture can appear on the lens as water condenses out of the warmer air. Condensation may occur when washing a vehicle with cold water on a warm day or when the lamps are warm and vice versa. This is the same phenomena as with the formation of dew on the surface of a glass window pane.

1. Moisture formation
2. Cool surfaces
3. Air circulation
4. Warm surfaces

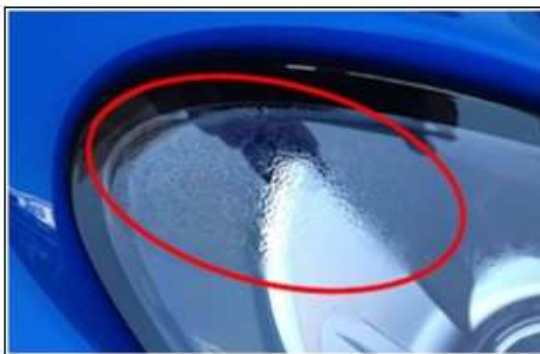
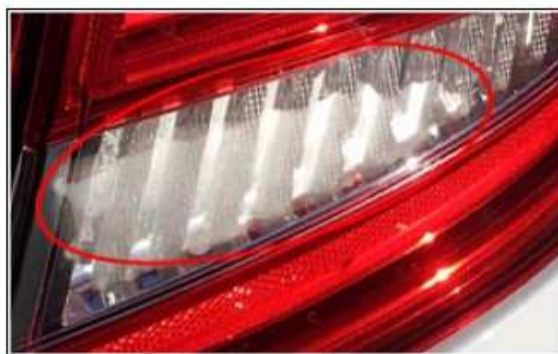
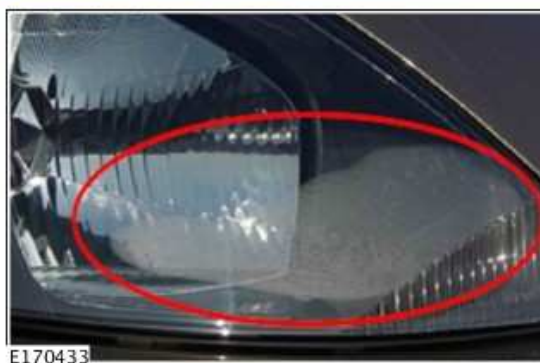
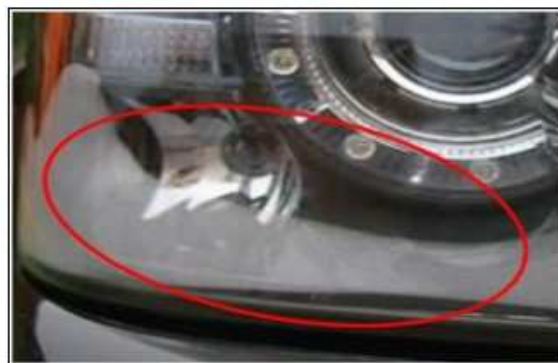
E170433

These are examples of normal exterior lamp condensation. This would NOT be covered by Warranty and the lamp should not be replaced.

3. No visible streaks, drip marks or droplets in the condensation mist.

Action: A lamp that exhibits condensation should be evaluated after a drying time where all the functions have been operated for a minimum of 30 minutes. If the condensation has started to clear during this time it indicates that the lamps sealing has NOT been breached and will eventually clear. The lamp must NOT be replaced.

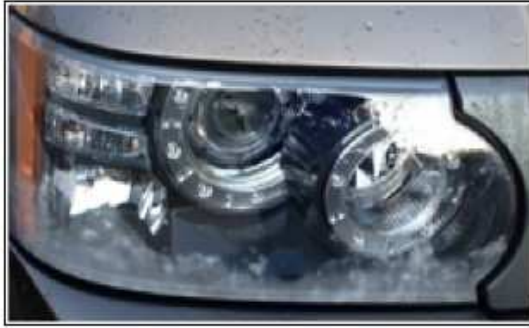
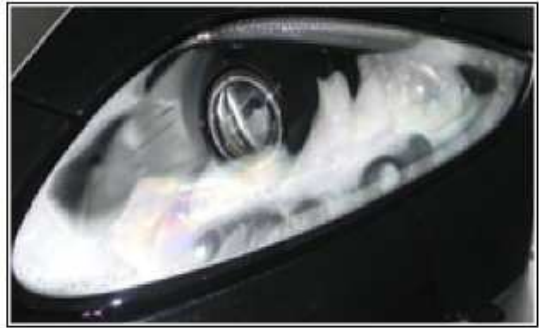
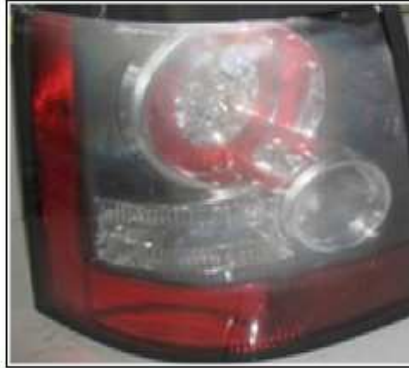
E170434

4. Condensation mist that

does not obstruct the view of the lamp interior.

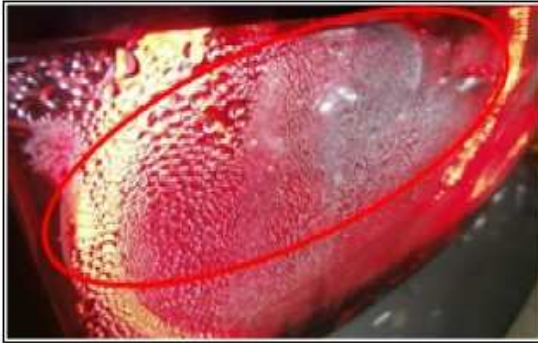
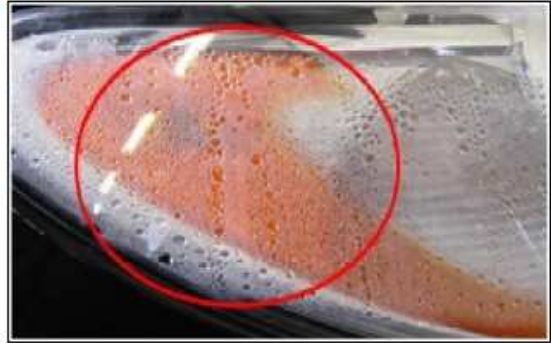
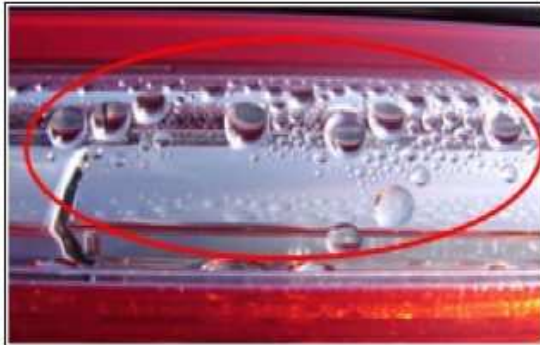
E170435

These are examples of abnormal exterior lamp condensation that may be covered by Warranty. Warranty may be accepted providing the lamp does not exhibit any visible signs of external damage.

5. Large water droplets.

NOTE: Pools of water and high levels of condensation would indicate that the lamps sealing has been compromised. Check for damage and inspect the condition of caps and breathers.

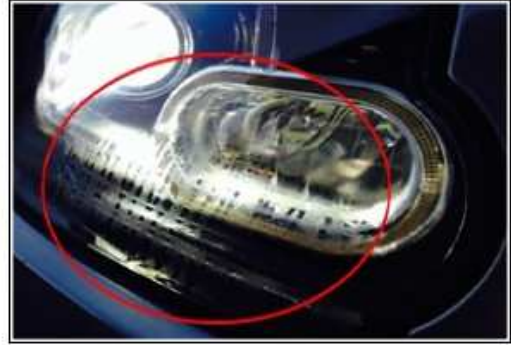
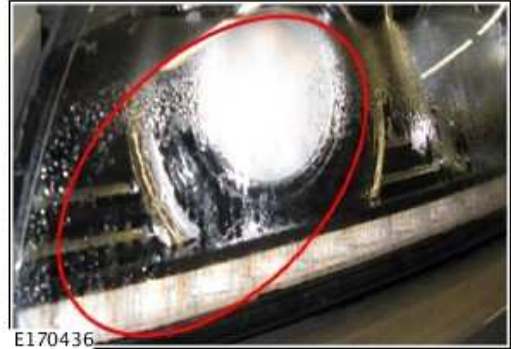
6. Drip marks or streaks in the condensation.

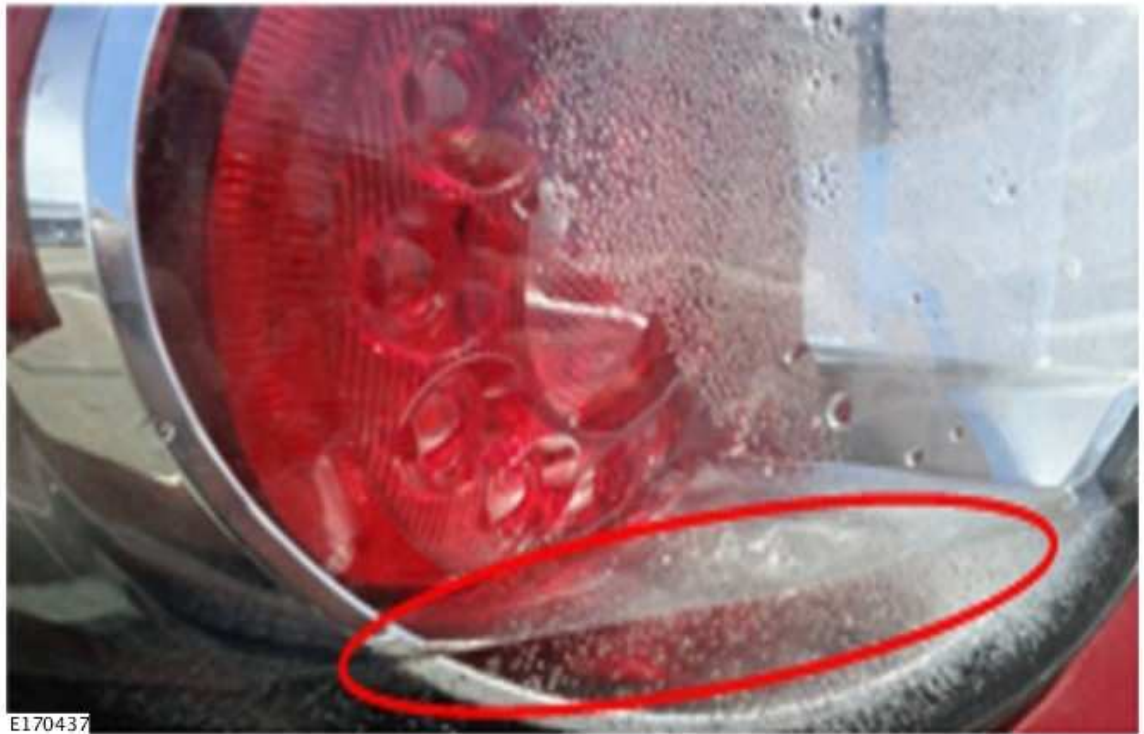
7. Standing water within the lamp.

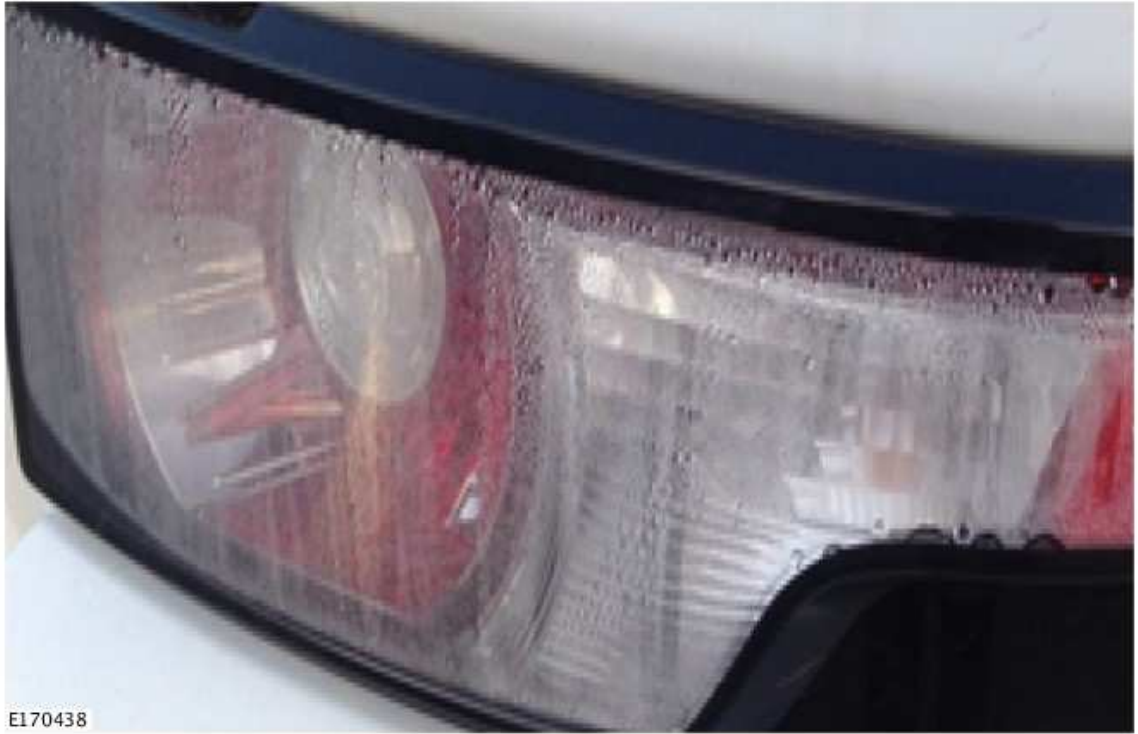
E170438

8. A thick mist covering the lens with water droplets.
