# M.I.L. "ON" DTC P0751

Category Drivetrain

Section Automatic Transmission/Transaxle Market USA

YEAR(S)	MODEL(S)	ADDITIONAL INFORMATION	
2008	IS250	Engine(s): 4GR Transmission(s): 6AT VDS(s): BK262, CK262 WMI(s): JTH

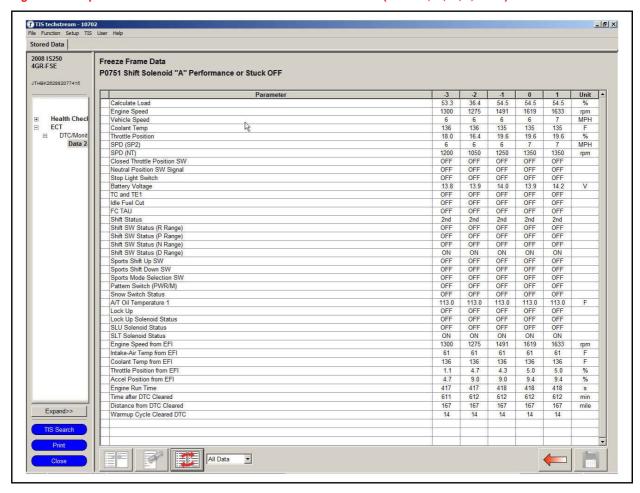
Figure 1. Example of Freeze Frame Data for P0751 with 5 Frames of Data (Titled -3, -2, -1, 0, and 1)

The DTC that is stored first will have 5 frames of Freeze Frame Data stored (see Figures 1 and 2).

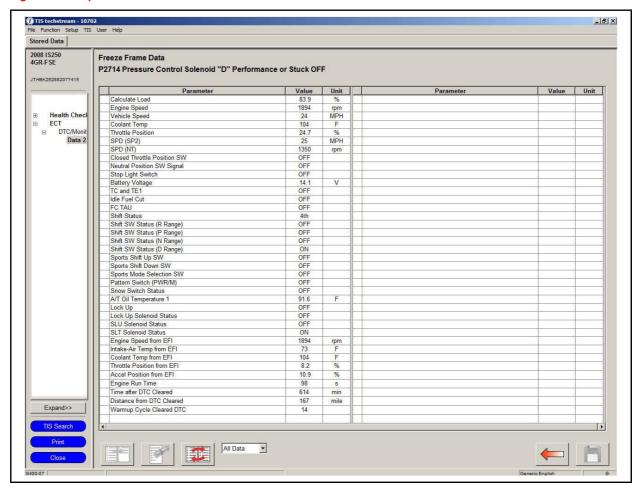
Figure 2. Example of Freeze Frame Data for P2714 with One Frame of Data

Does P0751 have 5 frames of Freeze Frame Data?

- YES Go to step 4.
- **NO** This TSIB does **NOT** apply. Refer to the Repair Manual and follow diagnosis for the first stored or primary DTC (the DTC with 5 frames of Freeze Frame Data).
- 4. Clear all codes and test drive vehicle. Monitor vehicle during test drive and confirm if abnormal shifting or a M.I.L. "ON" occurs.

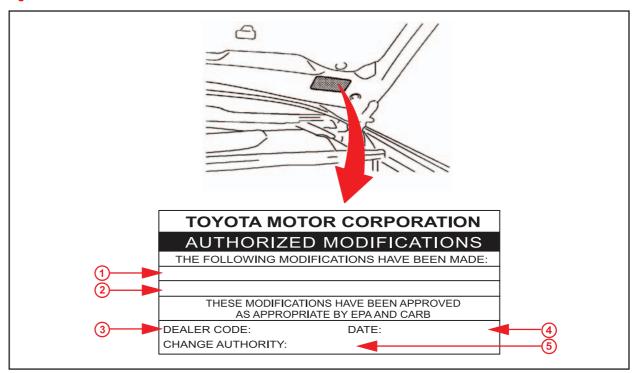
Figure 3. Location of Authorized Modifications Label on 2008 IS 250

- **YES** The recalibration in this bulletin has been previously performed. Refer to the Repair Manual for diagnosis.
- NO This TSIB applies. Go to step 6 for the ECM (PCM) reprogramming process.
- 6. Check for the Authorized Modifications Label affixed to the vehicle in the location shown in Figure 3. Confirm if the ECM (PCM) calibration has been updated. If the calibration ID listed is NOT the latest ECM (PCM) calibration go to step 7.

- 8. Install the Authorized Modifications Label.
  - A. Using a permanent marker, enter the following information on the label:
    - ECM part number [Refer to the Parts Information section for the CURRENT PART NUMBER]
    - Calibration ID(s) [Refer to the Calibration Identification Chart for the NEW CALIBRATION ID]
    - Dealer Code
    - Repair Date
    - Change Authority [This TSIB number]
  - B. Affix the Authorized Modifications Label to the vehicle at the location shown in Figure 3. The Authorized Modifications Label is available through the MDC, P/N 00451-00001-LBL.
- 9. Start the engine and warm it up to normal operating temperature before test driving.
- 10. Test drive the vehicle to confirm proper vehicle operation.
