Rear Driveshaft/Propeller Shaft Clunk/Thump Noise

Service Category Drivetrain

Section Drive Shaft/Propeller Shaft

Applicability

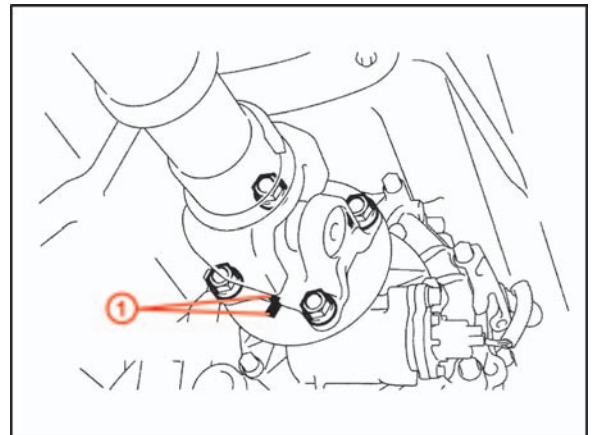
Figure 1.

1	Matchmarks
----------	-------------------

- (1) Remove the 4 nuts and 4 washers (propeller shaft to transfer flange).

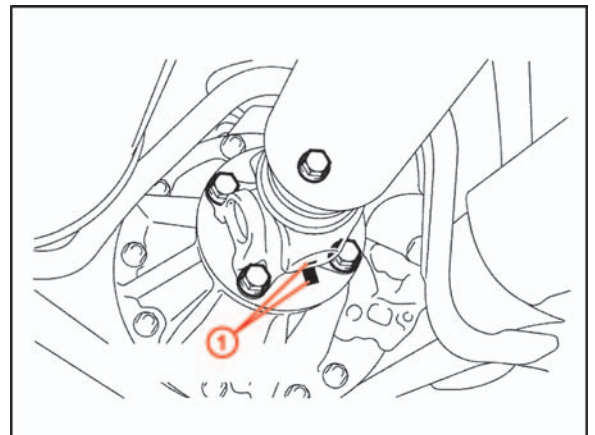
Figure 2.

1	Matchmarks
----------	-------------------

- (2) Remove the 4 nuts, 4 bolts, and 4 washers and then the propeller shaft assembly (propeller shaft to differential flange).

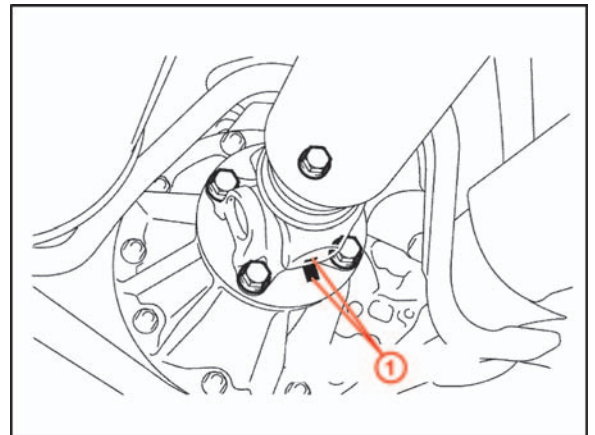
Figure 3.

1	Matchmarks
----------	-------------------

- (1) Align the matchmarks on the yoke and the differential flange.

- (2) Install the propeller shaft assembly with the 4 bolts, 4 nuts, and 4 washers.

Torque: 88 N*m (898 kgf*cm, 65 ft*lbf)

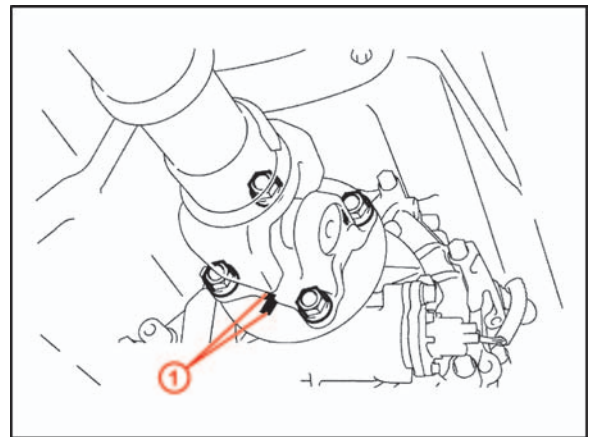
Figure 4.

1	Matchmarks
----------	-------------------

- (3) Align the matchmarks on the yoke and the transfer flange.

- (4) Install the propeller shaft assembly with the 4 nuts and 4 washers.

Torque: 88 N*m (898 kgf*cm, 65 ft*lbf)
