To All Lamborghini Dealers and Licensed Service Point
From Customer Service Department
Subject Rework for Bilstein shock absorber with Lifting System
Group L140.4.03
Attachments -
Date 12.07.2006
Pages 6

Rework for Bilstein shock absorber with Lifting System

All Gallardo (coupe & spyder) MY06 with Bilstein shock absorber and Lifting System from VIN 3072 to VIN 3813.

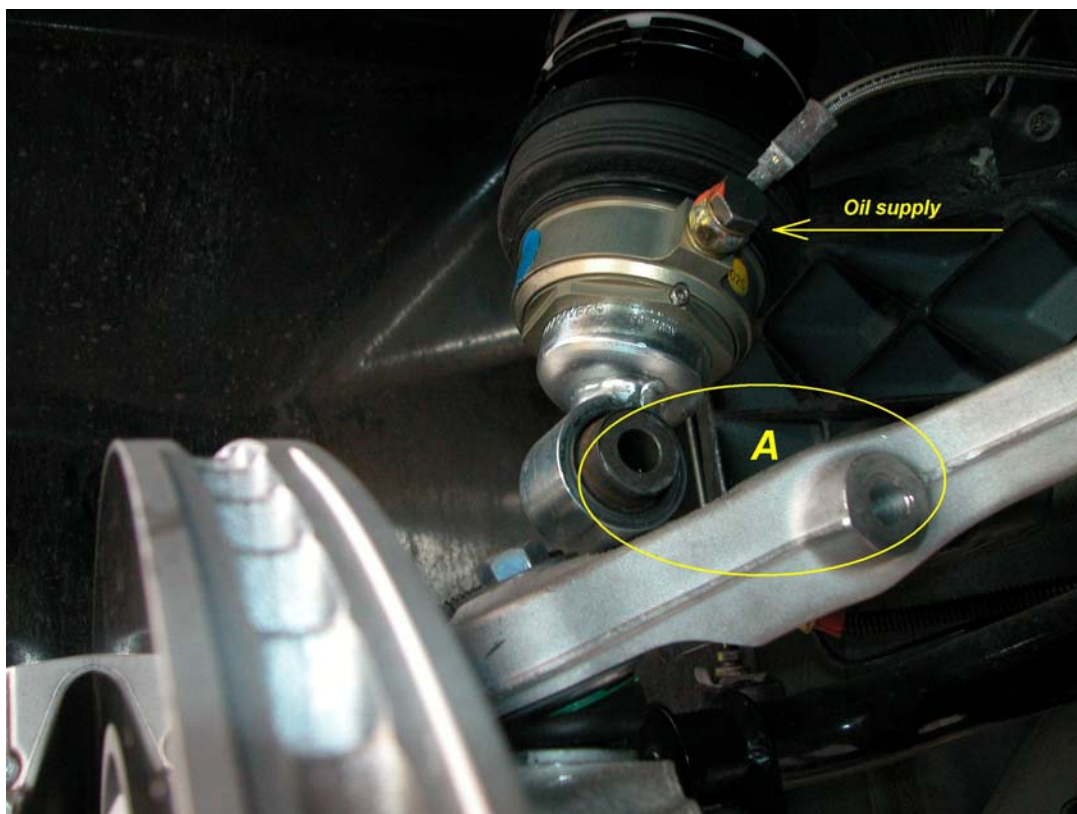
Pic. 1

This rework has to be done to avoid dirt entering in the Lifting System hydraulic piston.

- 1.2 Adopt all precautions to work safe and prevent damage to the car.
- 1.3 Disassemble the lower damper mount and the Lifting System oil supply line (picture 1).
