L624-A.02.16	To: Official After Sales Network Subject: Engine & gearbox SW update Date: March 18,2016 Pages 15

Engine & gearbox SW update

Huracan Coupè.

As a result of continuous product monitoring, Automobili Lamborghini Spa has found that on some vehicles the engine may sporadically stall during tip-in right after start, so then has made available a new software release for gearbox and engine.

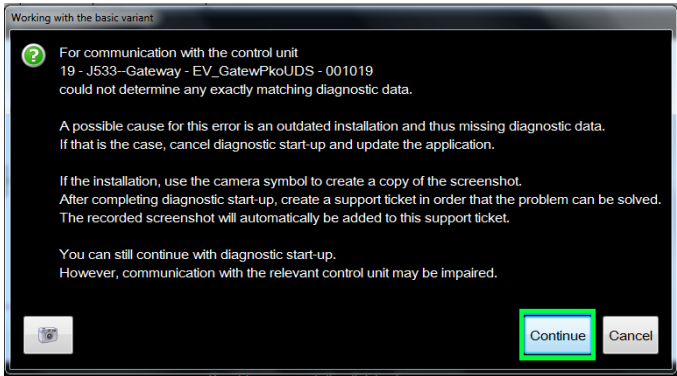
A. If the following dialogue box appears during ECUs identification:

Click “Continue”

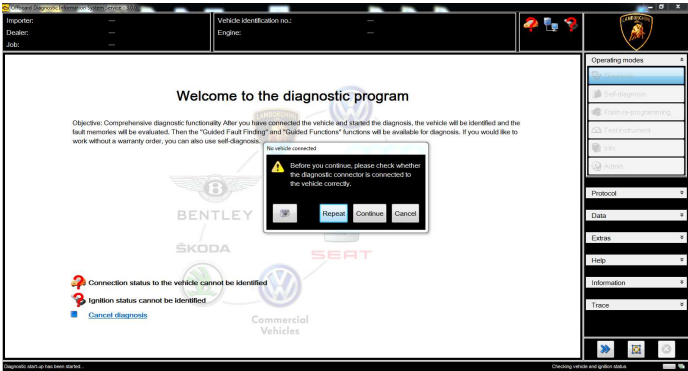
B. If the error message regarding the VAS5054 interface and the two icons for “on board connection” and “key status” are displayed as in the picture below:

- Click “Cancel”;
- Repeat the VAS5054 HW interface installation following the procedure (*) “VCI Manager v2.0”, by entering in the menu “Extras” on the right side and clicking “Diagnostic interface”.

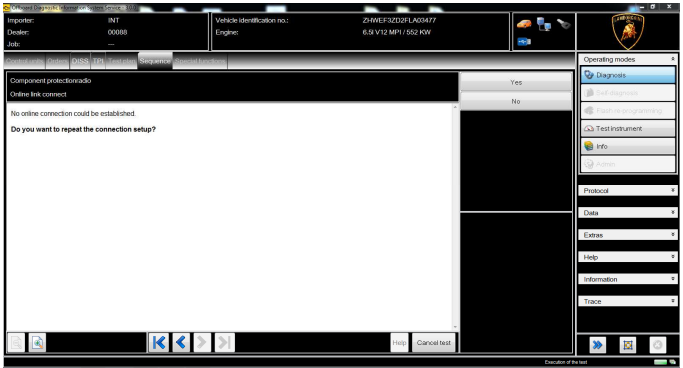
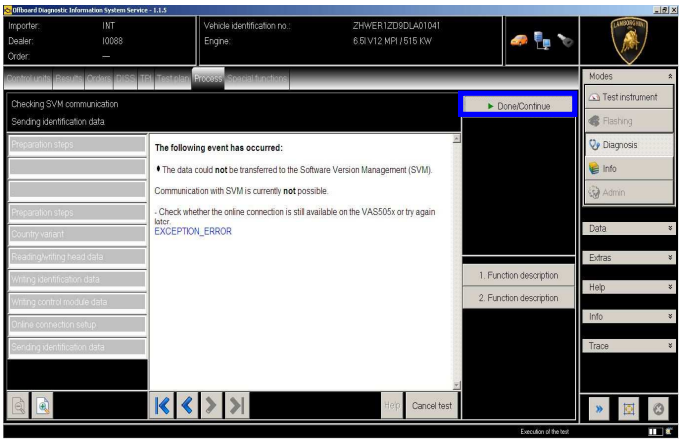
C. If one of the connection error screens is shown as in the pictures below:

- it is not possible to establish a connection with the central server. Please check carefully that the diagnosis laptop is properly connected to the internet network and retry clicking “Yes” or “Done/Continue”.

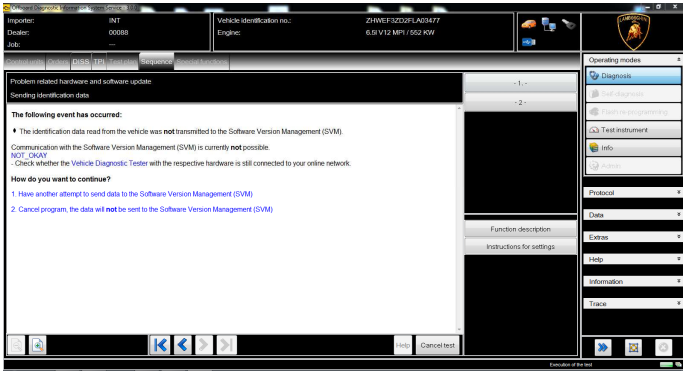
D. If the loss of connection happens during the target/actual comparison during SVM procedure:

- It is not possible to connect to central server, check the working connection of internet and retry clicking “1”.

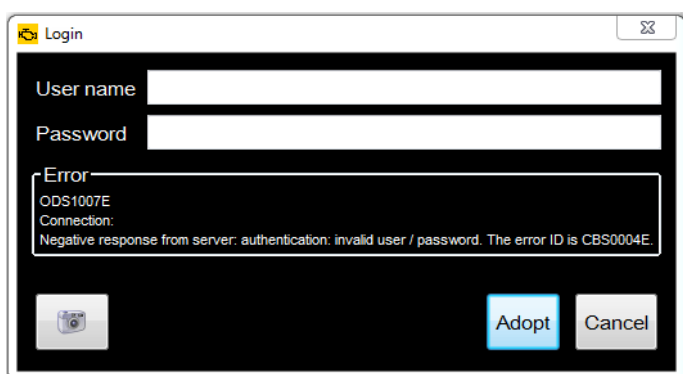
E. If the incorrect identification message is shown as in the picture below (error code: ODS1007E):

- be sure that your Geko account is valid;
- be sure that the label “Geko” is written on the token that you are using for the authentication;
- be sure the Password inserted is correct;
- click “Cancel” and perform the application test (see document “ODIS_Checking_ConnectionServer_SVM_2.0” (*)).

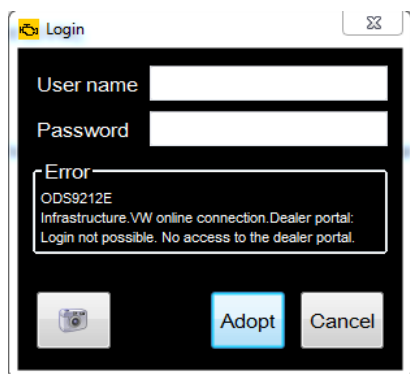
F. If the infrastructure error message is shown as in the picture below (error code: ODS9212E):

- make sure that your Geko account is valid
- check that the label “Geko” is written on the token that you are using for the authentication
- verify in ODIS settings you have “Internet” instead of “CPN” (see document “ODIS_Initial_Setup_2.0” (*))
- click on Cancel and perform the application test (see document “ODIS_Checking_ConnectionServer_SVM_2.0” (*))
