L624-
A.03.15

BCM1 software update

All Lamborghini Huracán 2015 starting from VIN FLA00163 to VIN FLA00500.

As a result of continuous product monitoring, Automobili Lamborghini Spa has found that in “Corsa “ drive mode the rear view camera stays on without any possibility to switch it off.

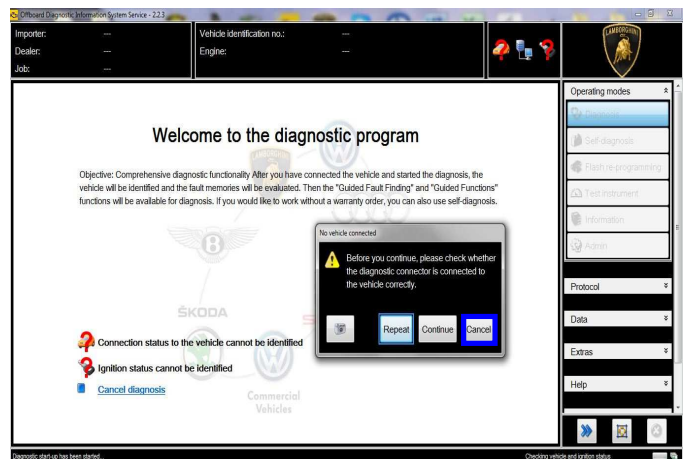
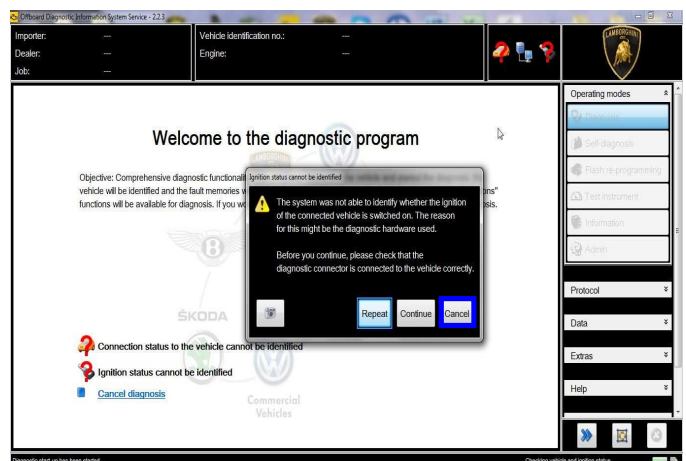
- If the error message regarding the VAS5054 interface and the 2 icons for status of on board connection and key on are shown as in the picture below:
 - Click **“Cancel”**;
 - Repeat the VAS5054 HW interface installation following the procedure (*) **“VCI Manager v2.0”**, by entering in the menu **“Extras”** on the right side and clicking on **“Diagnostic interface”**.

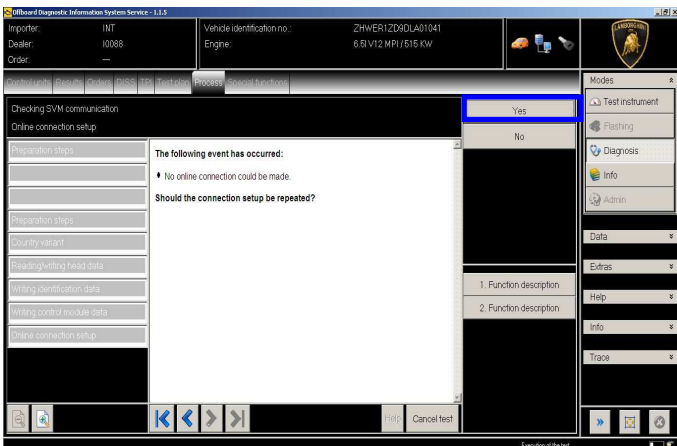
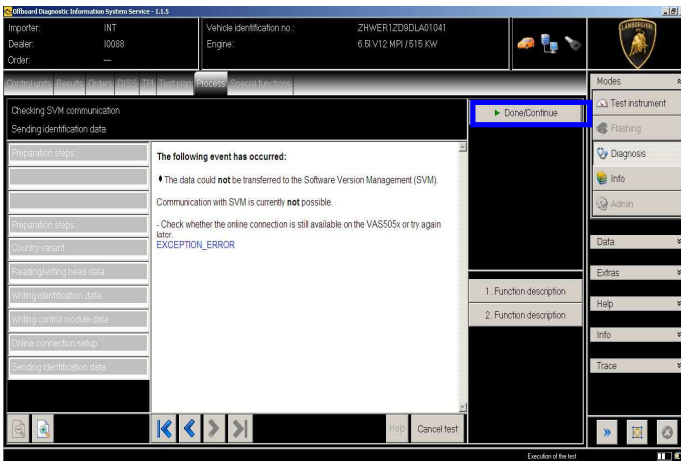
B. If one of the connection errors screens is shown as in the pictures below:

- it is not possible to establish a connection with the central server. Please check carefully that the diagnosis laptop is properly connected to the internet network and retry clicking “Yes” or “Done/Continue”.

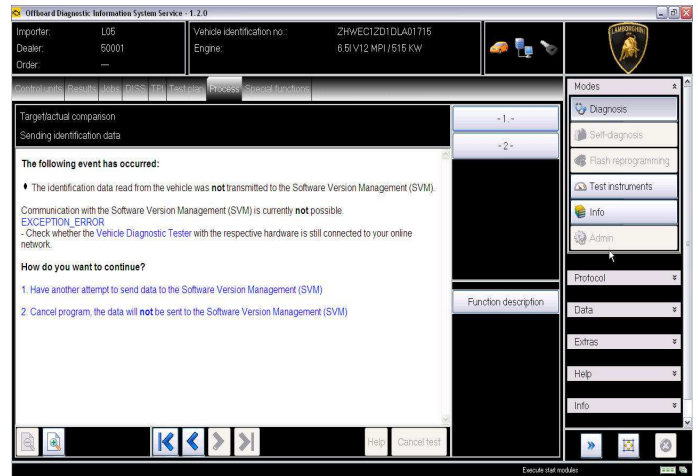
C. If the loss of connection happens during the target/actual comparison.

- It is not possible to connect to central server, check the working connection of internet and retry by clicking “1”.

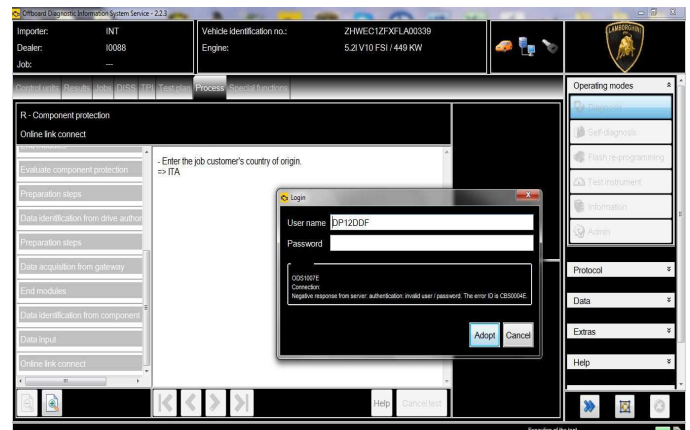
D. If the incorrect identification message is shown as in the picture below (error code: ODS1007E):

- be sure that your Geko account is valid;
- be sure that the label “Geko” is written on the token that you are using for the authentication;
- be sure the Password inserted is correct;
- click on Cancel and perform the application test (see document “ODIS_Checking_ConnectionServer_SVM_2.0” (*)).

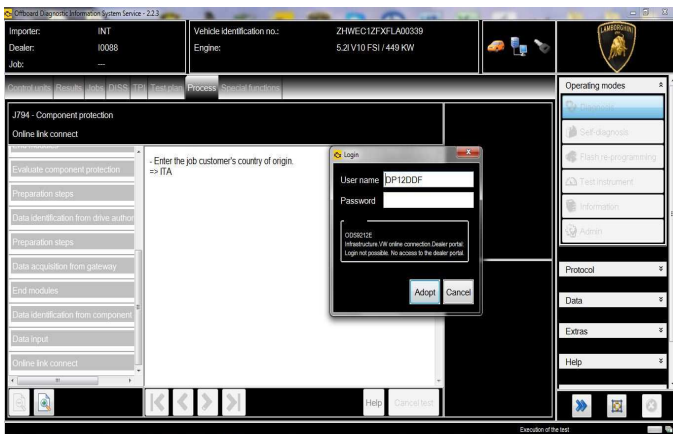
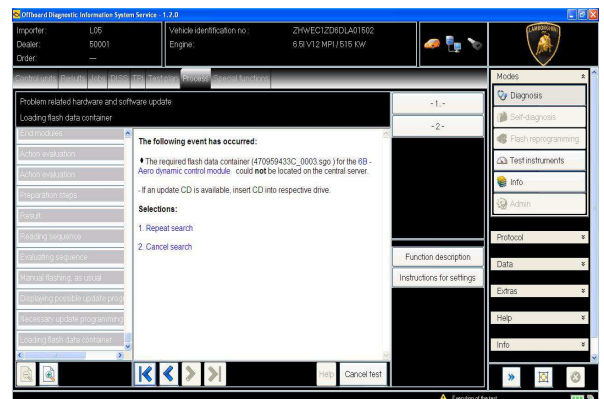
- F.** In the case the flash container is not detected (see figure):

If the same error was present during the application test, try following procedure:

- quit ODIS;
- Enter the folder C:\Program Files (x86)\Offboard_Diagnostic_Information_System_Service\automatic_sessions on your diagnosis laptop
