Haldex software update

All Lamborghini Huracán 2015 starting from VIN FLA00163 to FLA00541.

L624-
A.04.15

To: Official After Sales Network
Subject: Haldex software update
Date: 02/20/2015
Pages: 14

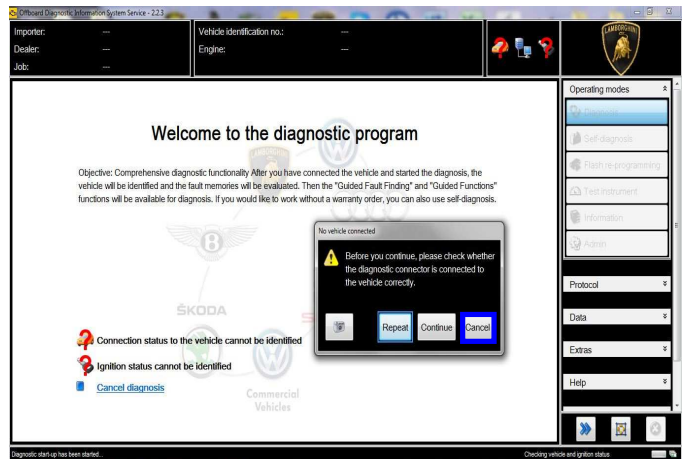
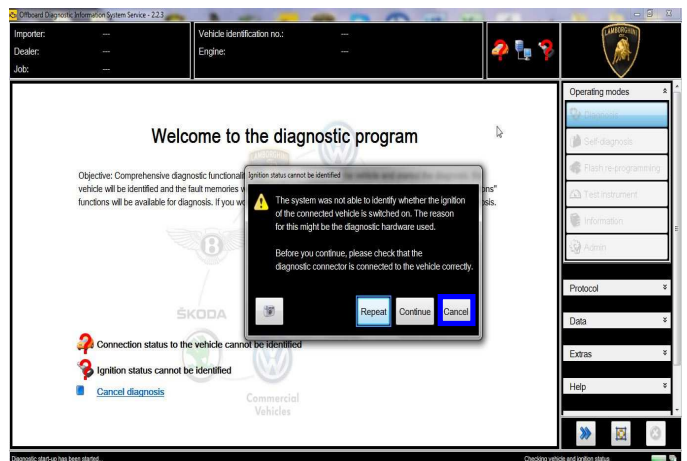
- A. If the error message regarding the VAS5054 interface and the 2 icons for status of on board connection and key on are shown as in the picture below:

- Click **“Cancel”**;
- Repeat the VAS5054 HW interface installation following the procedure (*) **“VCI Manager v2.0”**, by entering in the menu **“Extras”** on the right side and clicking on **“Diagnostic interface”**.

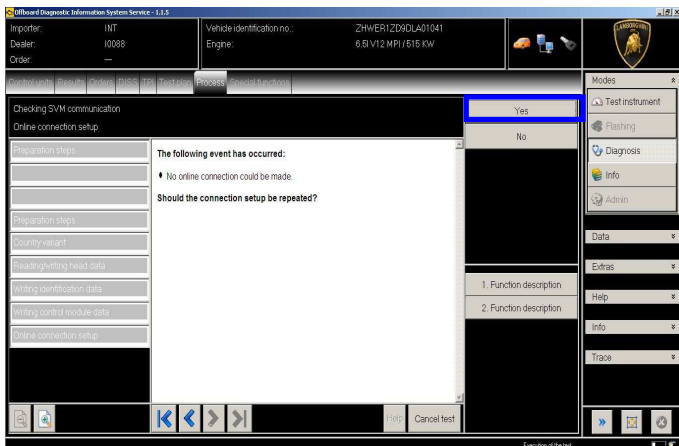
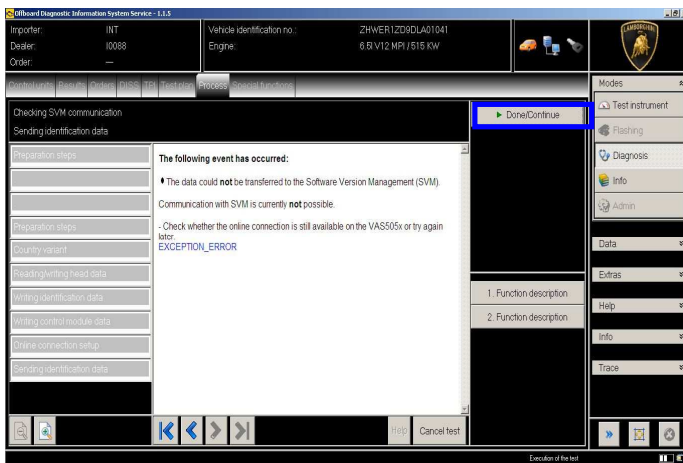
B. If one of the connection errors screens is shown as in the pictures below:

- it is not possible to establish a connection with the central server. Please check carefully that the diagnosis laptop is properly connected to the internet network and retry clicking “Yes” or “Done/Continue”.

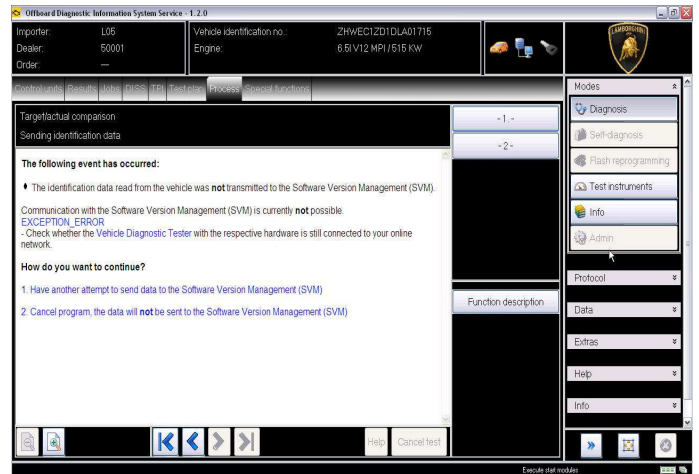
C. If the loss of connection happens during the target/actual comparison.

- It is not possible to connect to central server, check the working connection of internet and retry by clicking “1”.

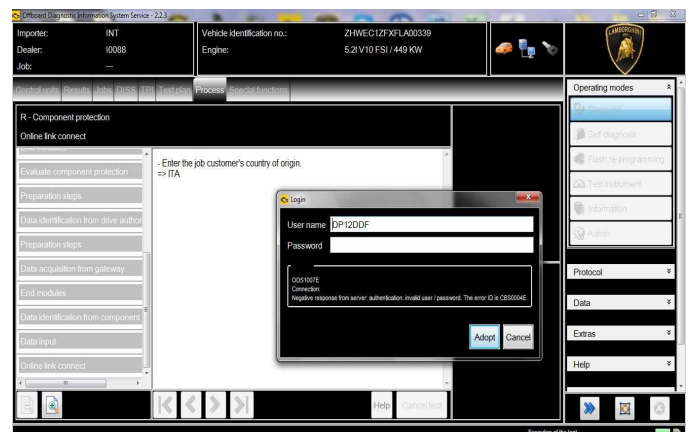
D. If the incorrect identification message is shown as in the picture below (error code: ODS1007E):

- be sure that your Geko account is valid;
- be sure that the label “Geko” is written on the token that you are using for the authentication;
- be sure the Password inserted is correct;
- click on Cancel and perform the application test (see document “ODIS_Checking_ConnectionServer_SVM_2.0” (*)).
