L624-
A.05.15

AC System software update

All Lamborghini Huracán 2015 Right Hand drive starting from VIN 00163 to FLA01968

As a result of continuous product monitoring, Automobili Lamborghini Spa has introduced a new software enhance the air recycle functionality.

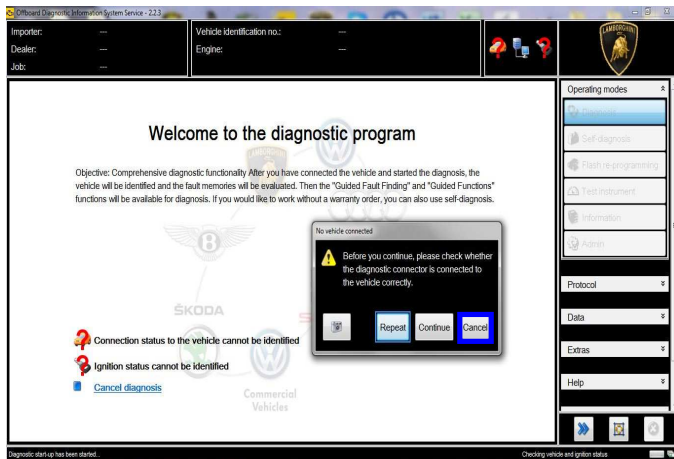
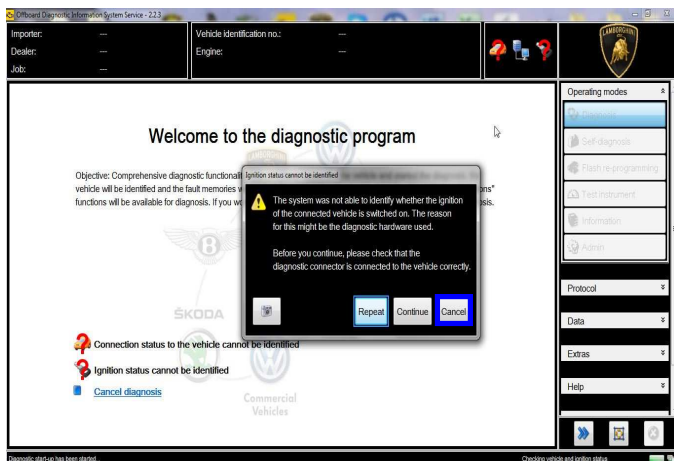
A. If the error message regarding the VAS5054 interface and the 2 icons for status of on board connection and key on are shown as in the picture below:

- Click “Cancel”;
- Repeat the VAS5054 HW interface installation following the procedure (*) “VCI Manager v2.0”, by entering in the menu “Extras” on the right side and clicking on “Diagnostic interface”.

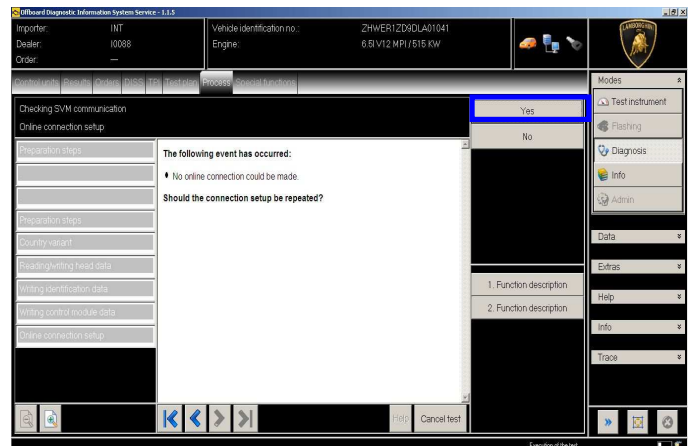
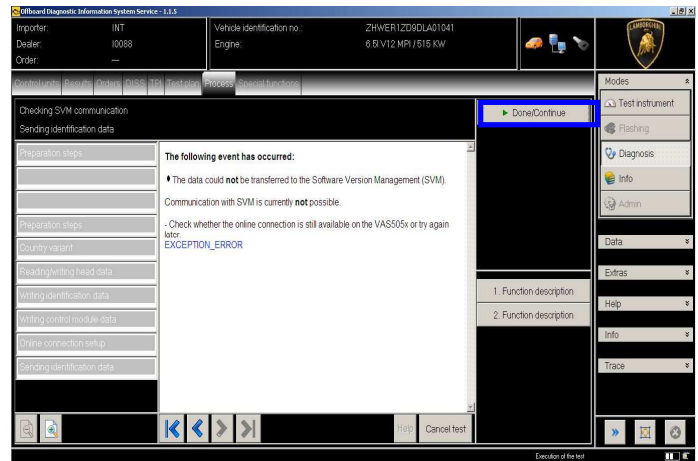
B. If one of the connection errors screens is shown as in the pictures below:

- it is not possible to establish a connection with the central server. Please check carefully that the diagnosis laptop is properly connected to the internet network and retry clicking “Yes” or “Done/Continue”.

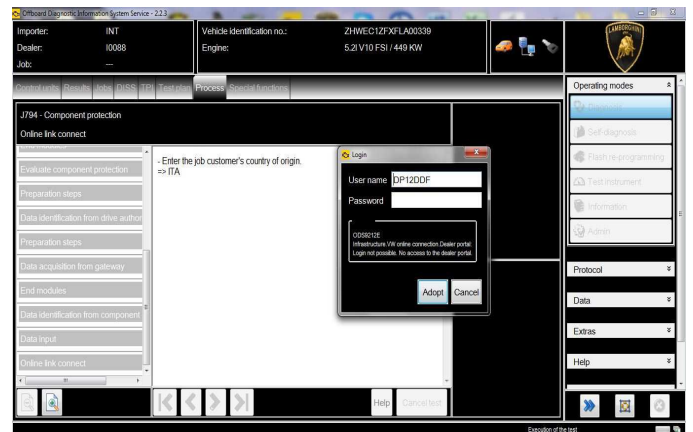
E. If the infrastructure error message is shown as in the picture below (error code: ODS9212E):

- be sure that your Geko account is valid
- be sure that the label “Geko” is written on the token that you are using for the authentication
- verify in ODIS settings you have “Internet” instead of “CPN” (see document “ODIS_Initial_Setup_2.0” (*))
- click on Cancel and perform the application test (see document “ODIS_Checking_ConnectionServer_SVM_2.0” (*))
