L624-
A.06.15

SMLS software update

All Lamborghini Huracan 2015 starting from VIN FLA00163 to FLA00752.

As a result of continuous product monitoring, Automobili Lamborghini Spa has found that in real particular circumstances of manoeuvring the SMLS could not be calibrated.

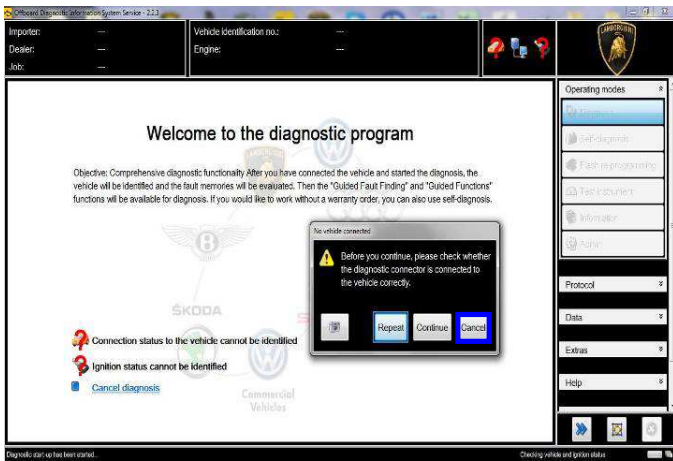
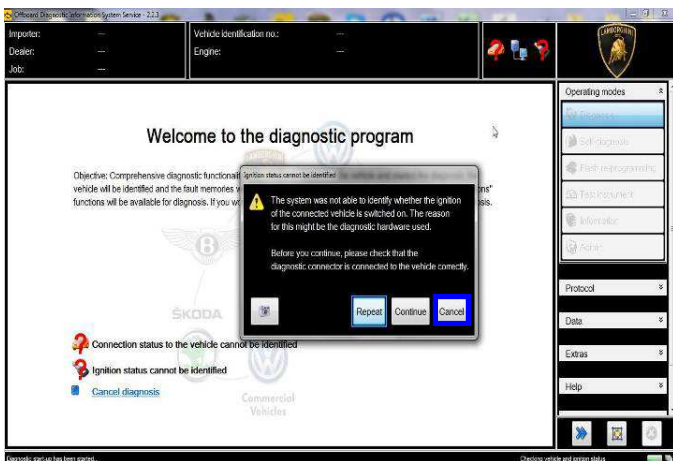
A. If the error message regarding the VAS5054 interface and the 2 icons for status of on board connection and key on are shown as in the picture below:

- Click “Cancel”;
- Repeat the VAS5054 HW interface installation following the procedure (*) “VCI Manager v2.0”, by entering in the menu “Extras” on the right side and clicking on “Diagnostic interface”.

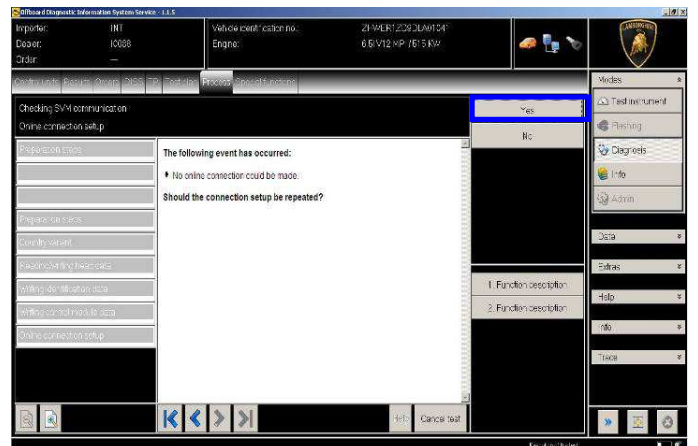
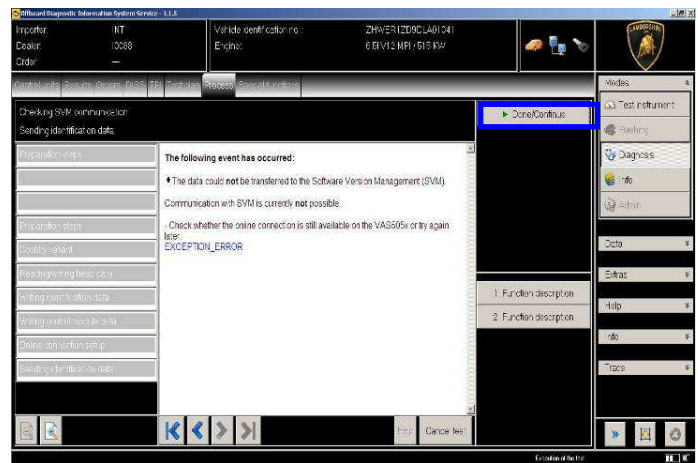
B. If one of the connection errors screens is shown as in the pictures below:

- it is not possible to establish a connection with the central server. Please check carefully that the diagnosis laptop is properly connected to the internet network and retry clicking “Yes” or “Done/Continue”.

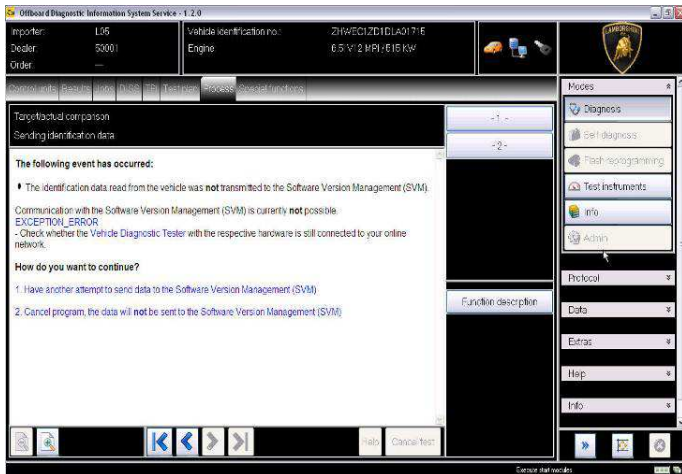
D. If the incorrect identification message is shown as in the picture below (error code: ODS1007E):

- be sure that your Geko account is valid;
- be sure that the label “Geko” is written on the token that you are using for the authentication;
- be sure the Password inserted is correct;
- click on Cancel and perform the application test (see document “ODIS_Checking_ConnectionServer_SVM_2.0” (*)).

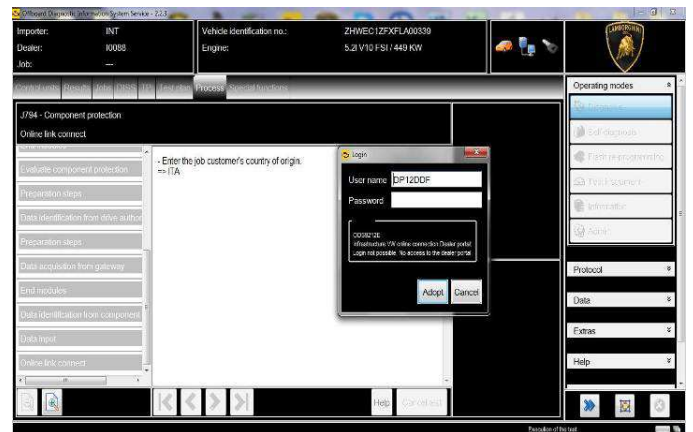
E. If the infrastructure error message is shown as in the picture below (error code: ODS9212E):

- be sure that your Geko account is valid
- be sure that the label “Geko” is written on the token that you are using for the authentication
- verify in ODIS settings you have “Internet” instead of “CPN” (see document “ODIS_Initial_Setup_2.0” (*))
- click on Cancel and perform the application test (see document “ODIS_Checking_ConnectionServer_SVM_2.0” (*))
